SWR INSTITUTE TRINITY AWARD SUBMISSION

Exterior Wall and Roof Repairs, The 1717 Rhode Island Avenue Building, Washington, DC

1717 Rhode Island Avenue NW, Washington, DC

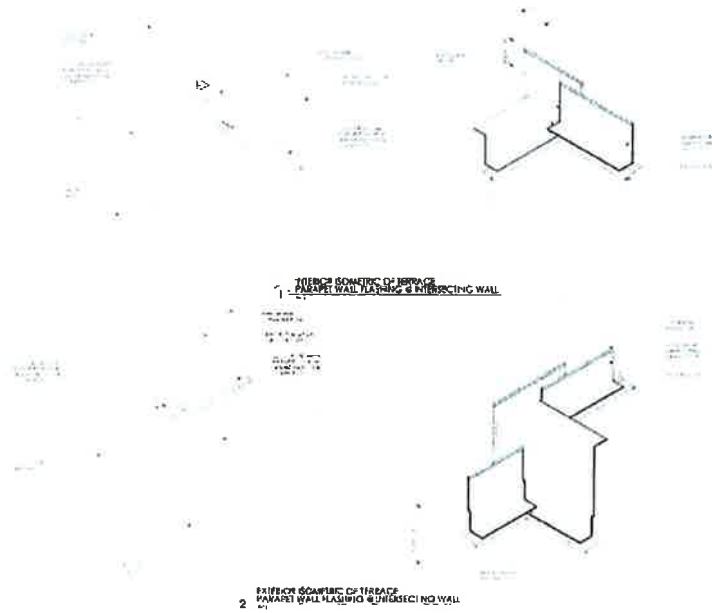
1. Replacement of through-wall flashing at existing shelf angles, lintels, terrace parapet coping caps, base of rising walls above terraces, gable wall coping caps, and window sills to address deficiencies in original through-wall flashing (Figures 2 through 4).

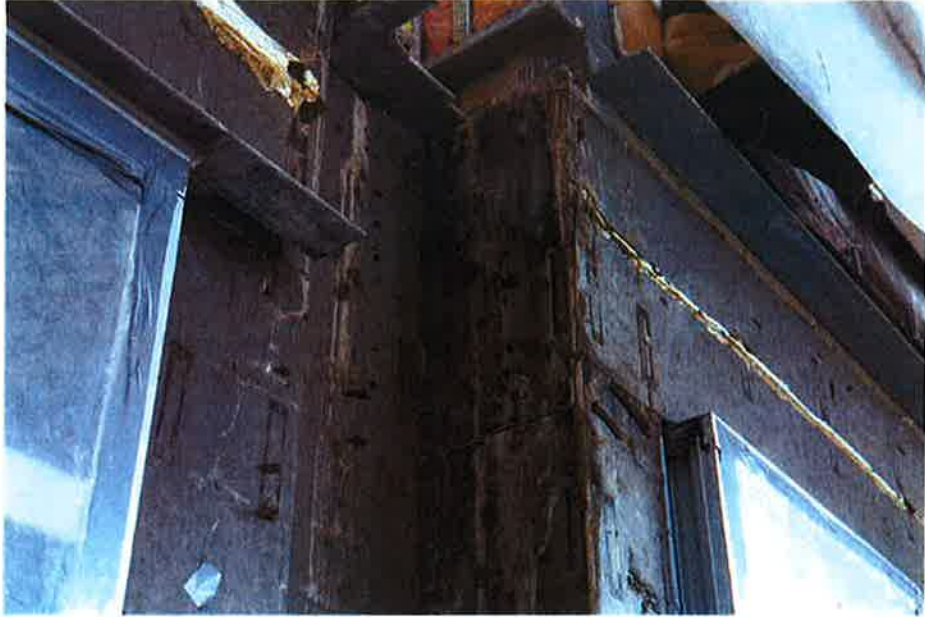
Figure 7

1. Based on the required repairs, removal of the brick and limestone masonry was originally only required above the shelf angles and window lintels, at the window jambs, below the window sills, and at the terrace parapet walls. However, during the initial phases of demolition, it became clear that there were significant deficiencies with the existing WRB. At many locations the WRB was missing, not continuous, sagging away from the exterior sheathing, included holes, or was reversed lapped (Figures 5 and 6). These deficiencies were observed throughout the facade wherever masonry was removed. The deficiencies in the WRB also caused deterioration of the underlying exterior wall sheathing and metal studs at many locations (Figure 7). For these reasons, it was decided to remove 100% of the

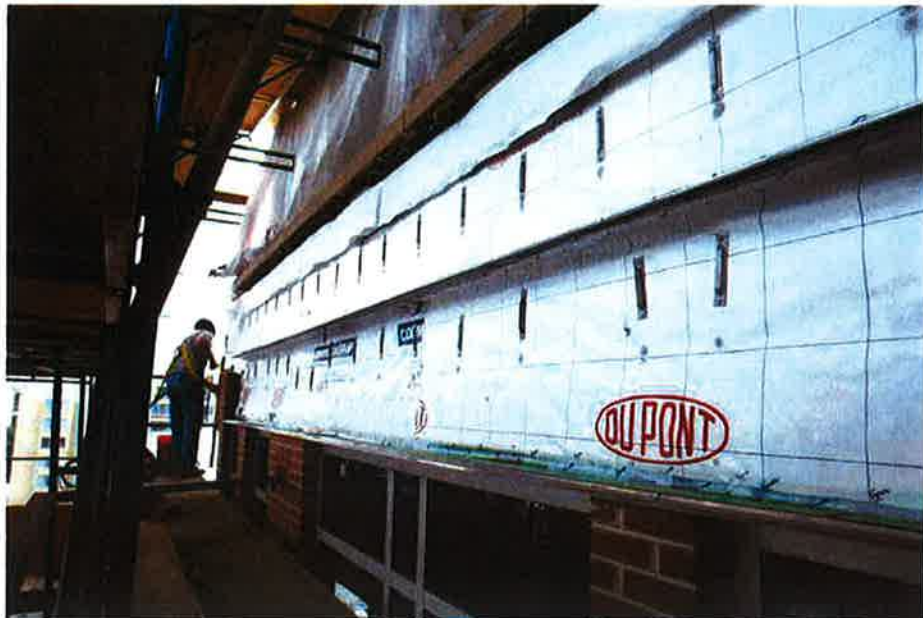
Figure 8

brick and limestone masonry from the exterior walls so that the existing WRB could be completely replaced with a continuous and properly installed WRB (Figure 8). Although this added a significant amount of work to the project, the overall impact on cost and schedule was minimal due to thorough and efficient planning.

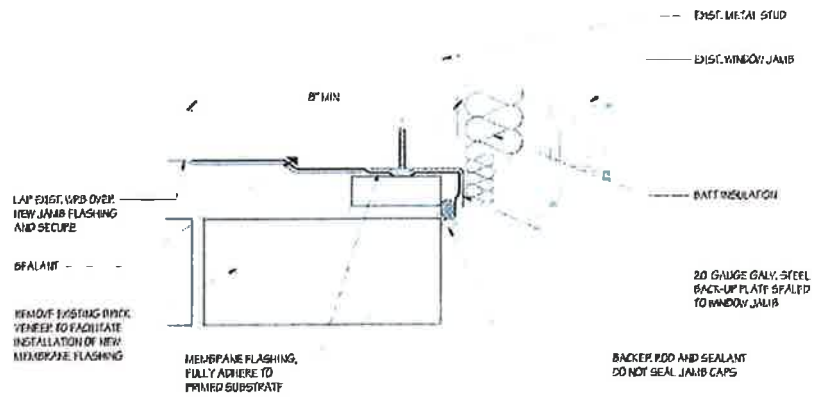
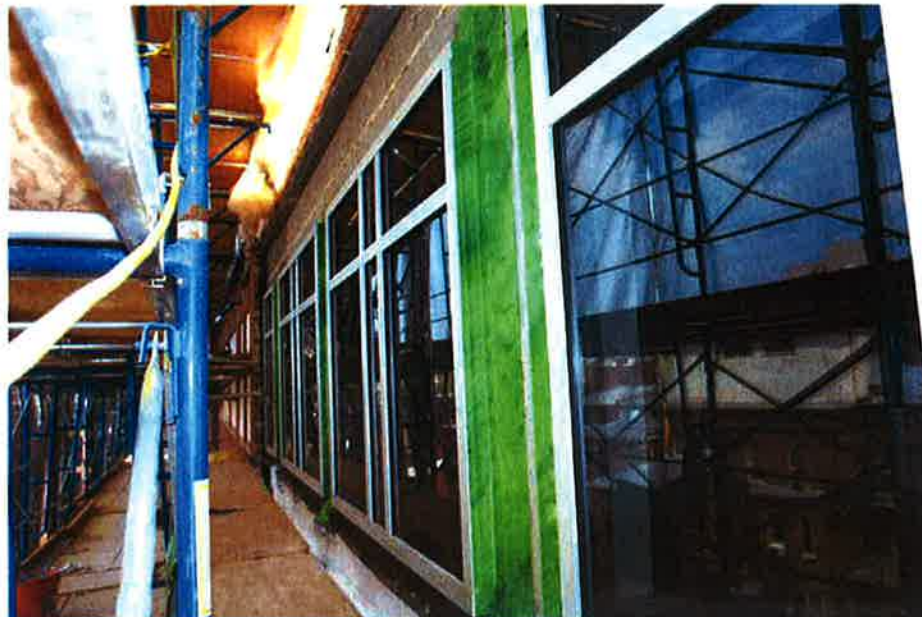
1. The window frames were “C” shaped, open to the masonry wall cavity, and not configured to easily receive new jamb flashing. As such, a new backup plate was required to be tucked into the window frame and attached to the adjacent backup materials to provide an adequate surface to support the new jamb flashing (Figures 9 and 10).
