# SWR Institute Trinity Project Awards Program

Project Title: First National Bank - Facade Repairs & Rehabilitation

Location: Richmond, VA

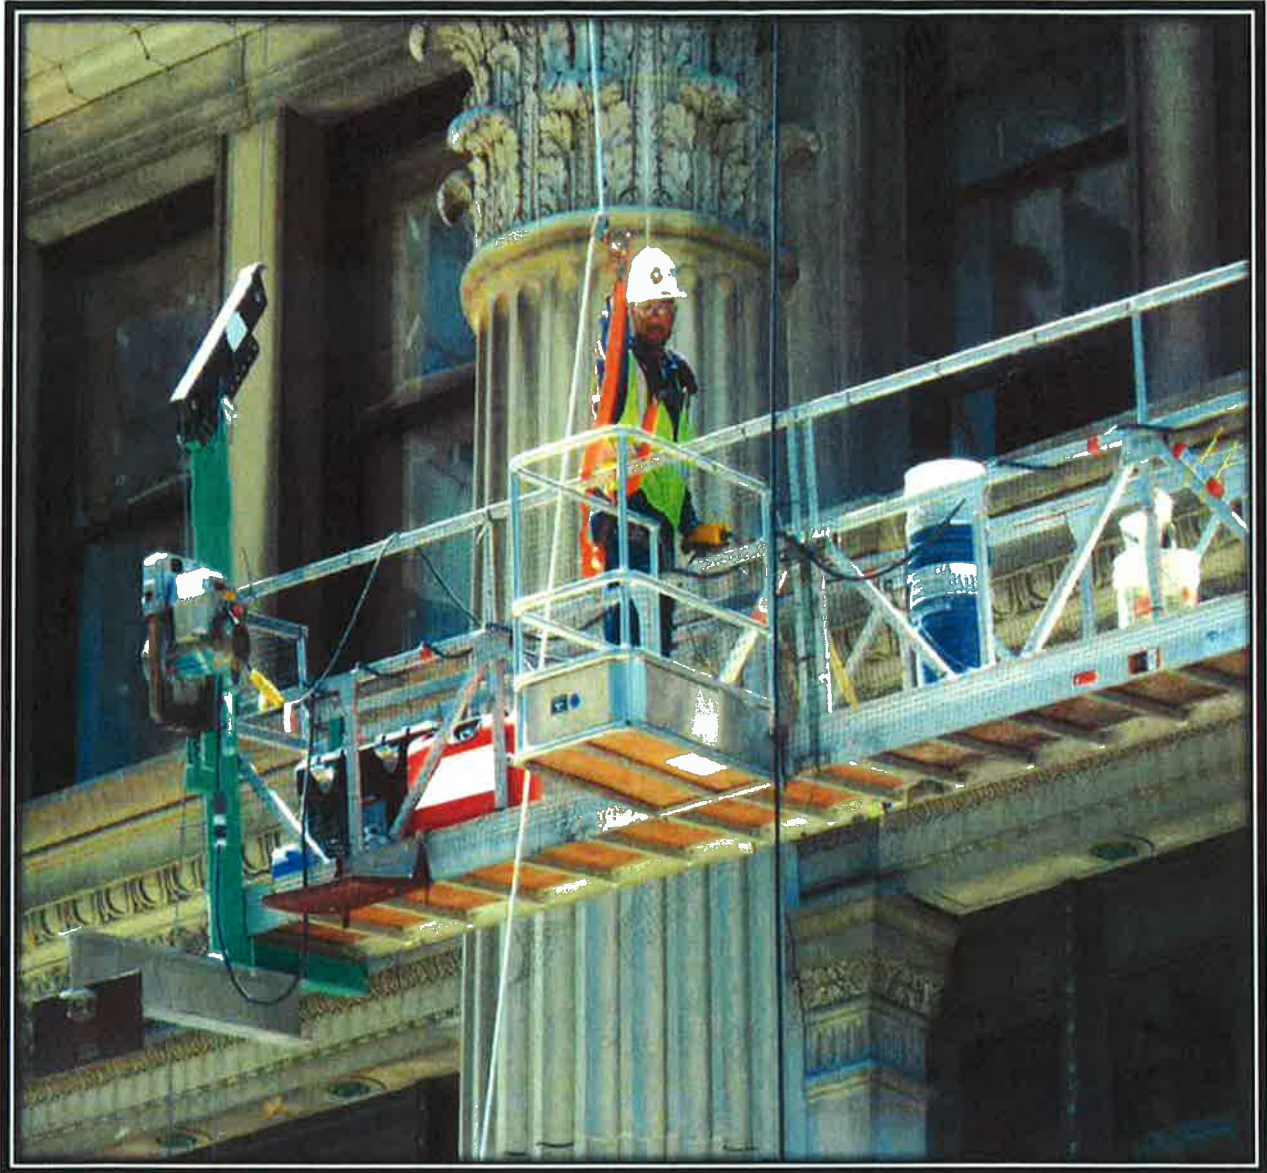
**Porch bracket example depicting extending upper level work access**

- 8) Buck hoist drop: Detrimental impact with overall project duration. Mitigated by extra man on stage attempting to compress two month duration.
- 9) Upper level recessed windows: five foot recess mitigated by stage company furnishing a “porch” bracket with counter weights thus allowing workers closer access to the façade.

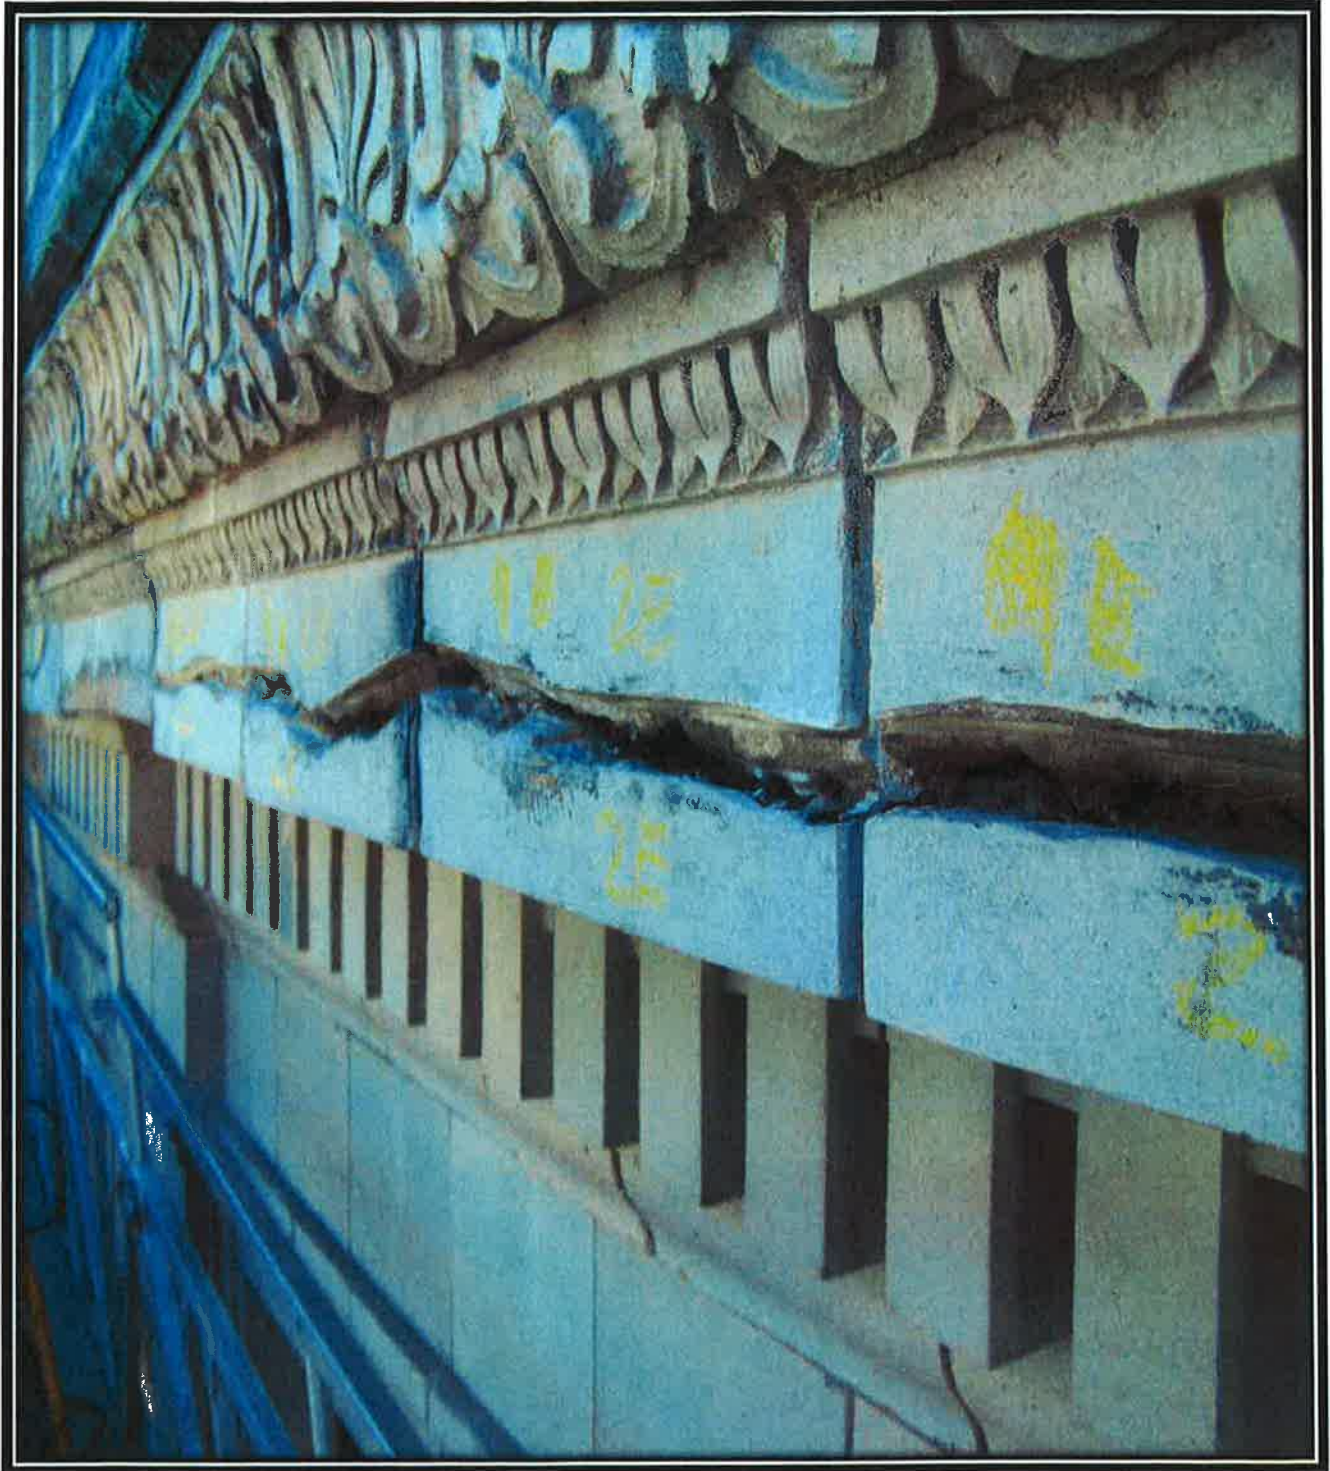
In many major cities, a focus has been on the monitoring wearing condition of the hi-rise building facade fabric. This structure was subjected to scrutiny due to public safety concerns associated with loose sheet metal panels blown off during a tropical storm event and spalled sections of terra-cotta falling to the ground.

Terra-Cotta distress

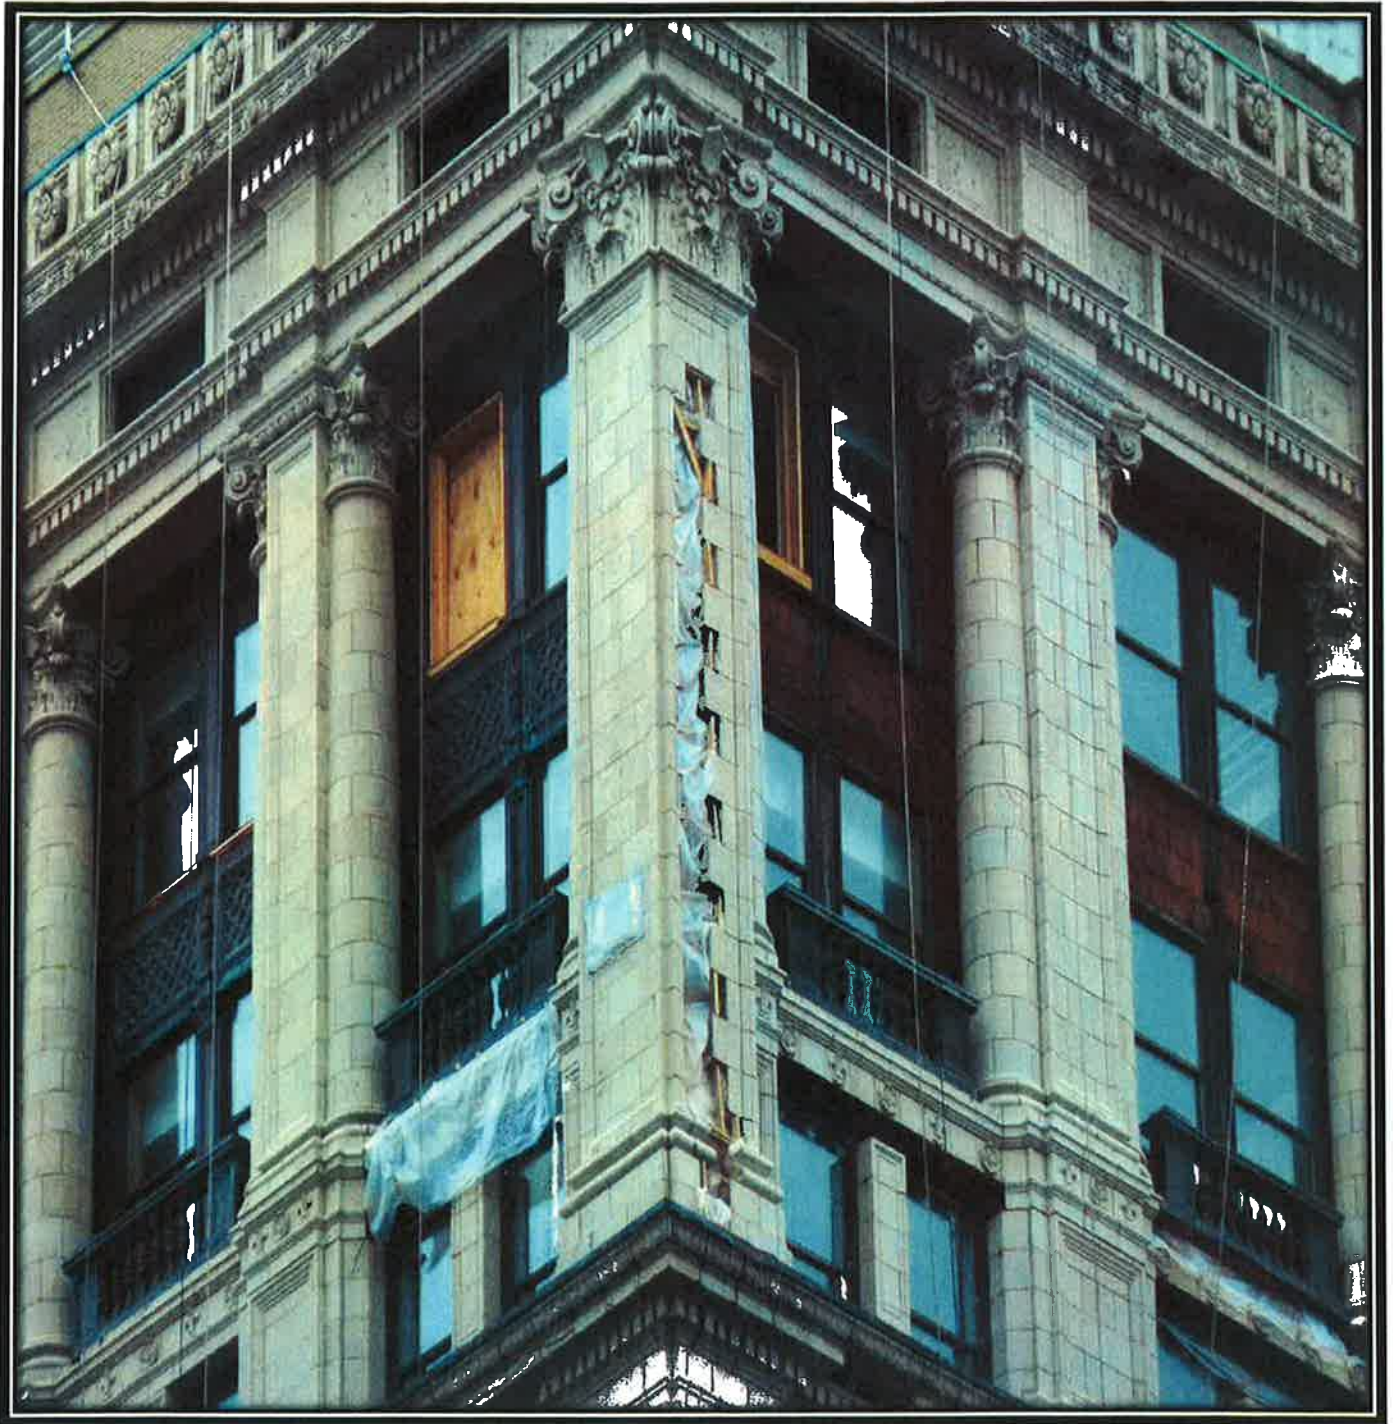
Terra-Cotta replacement

- 1) Terra-cotta replacement pieces: Detrimental material delivery scheduling impact was mitigated via adjusting material needs per stage drop so that visible street side work was completed first.

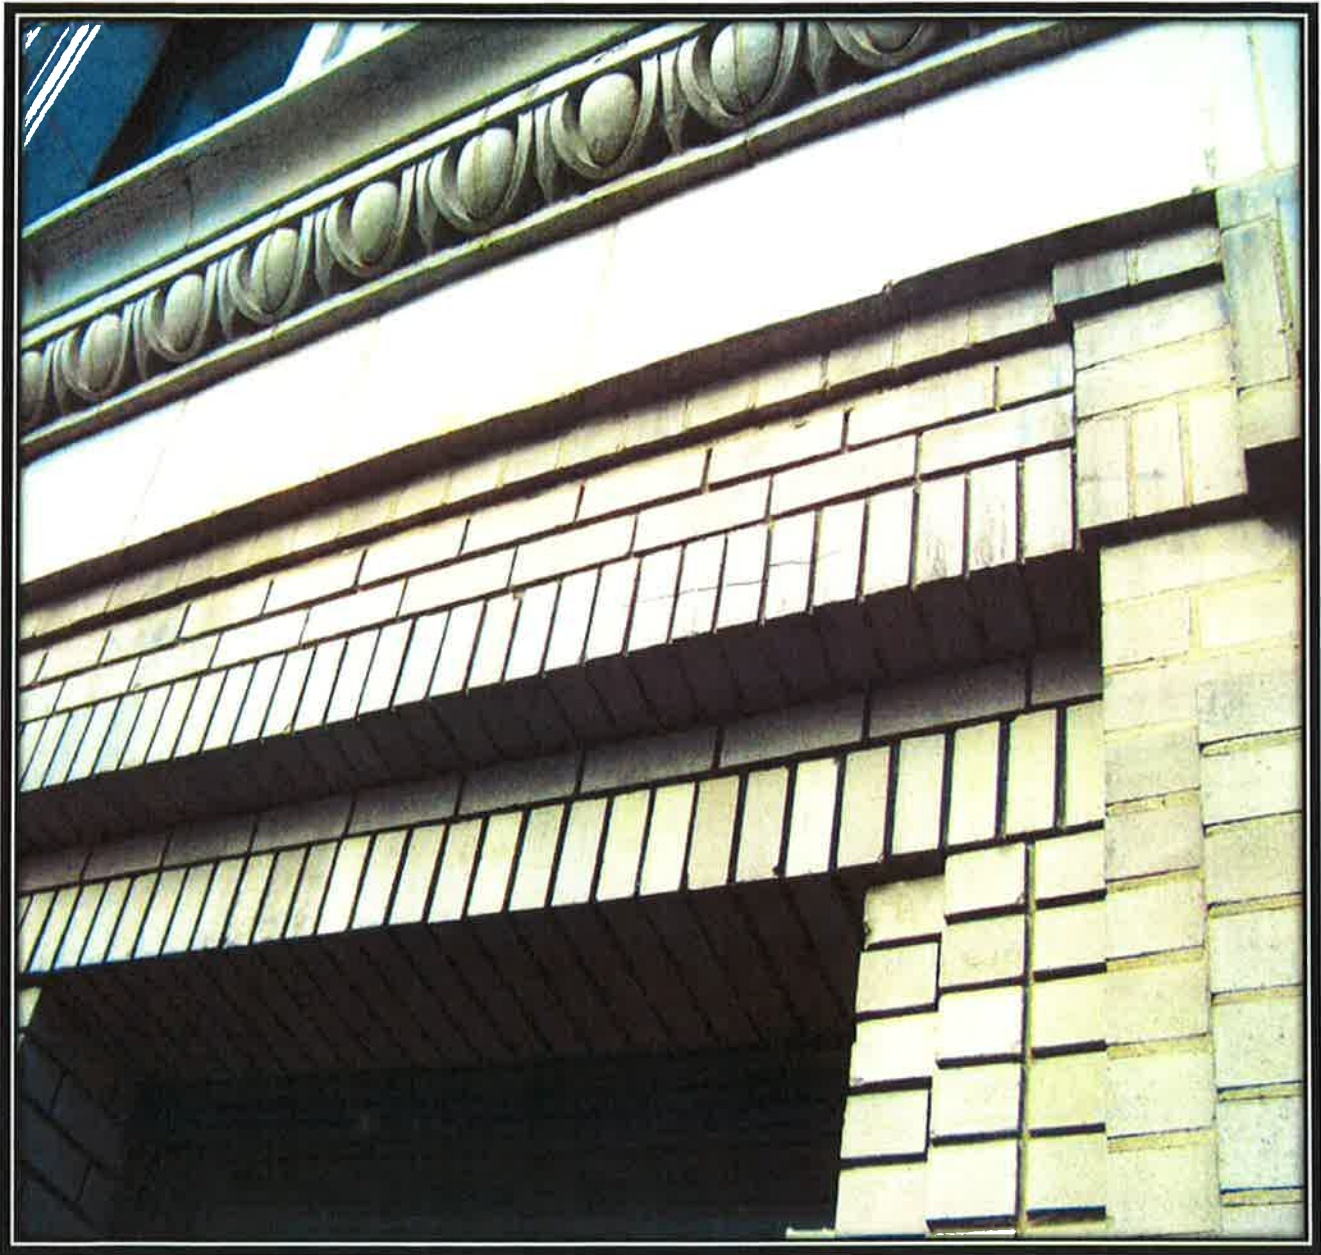
**Example of brick lintel to replace**

- 3) Brick lintel: Means and methods left up to the specialty contractor who ultimately fabricated at their shop and shipped in single sections.
- 4) General contractor communications: Difficulty in maintaining G/C project manager focus. Mitigated matters via generating minutes used to reflect back on actual dialogue.

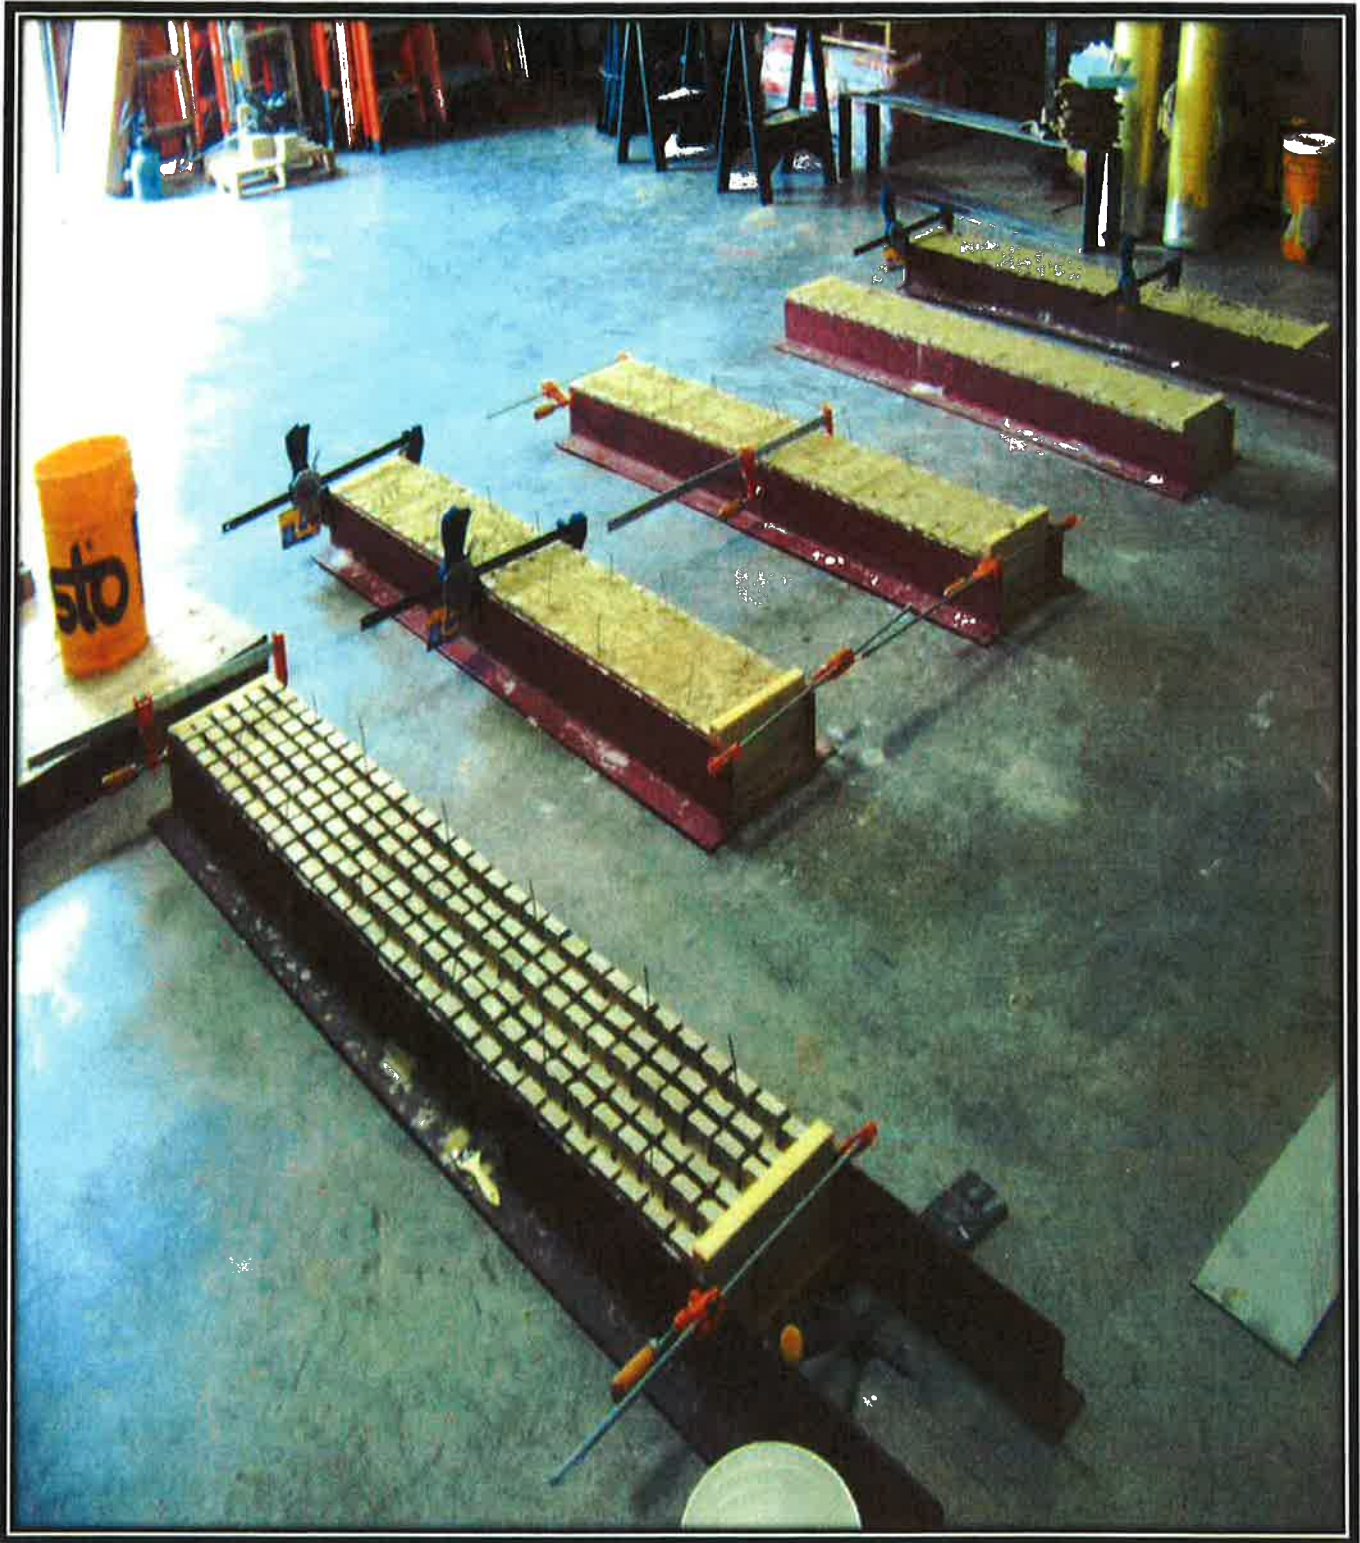
Shop fabrication of brick lintels

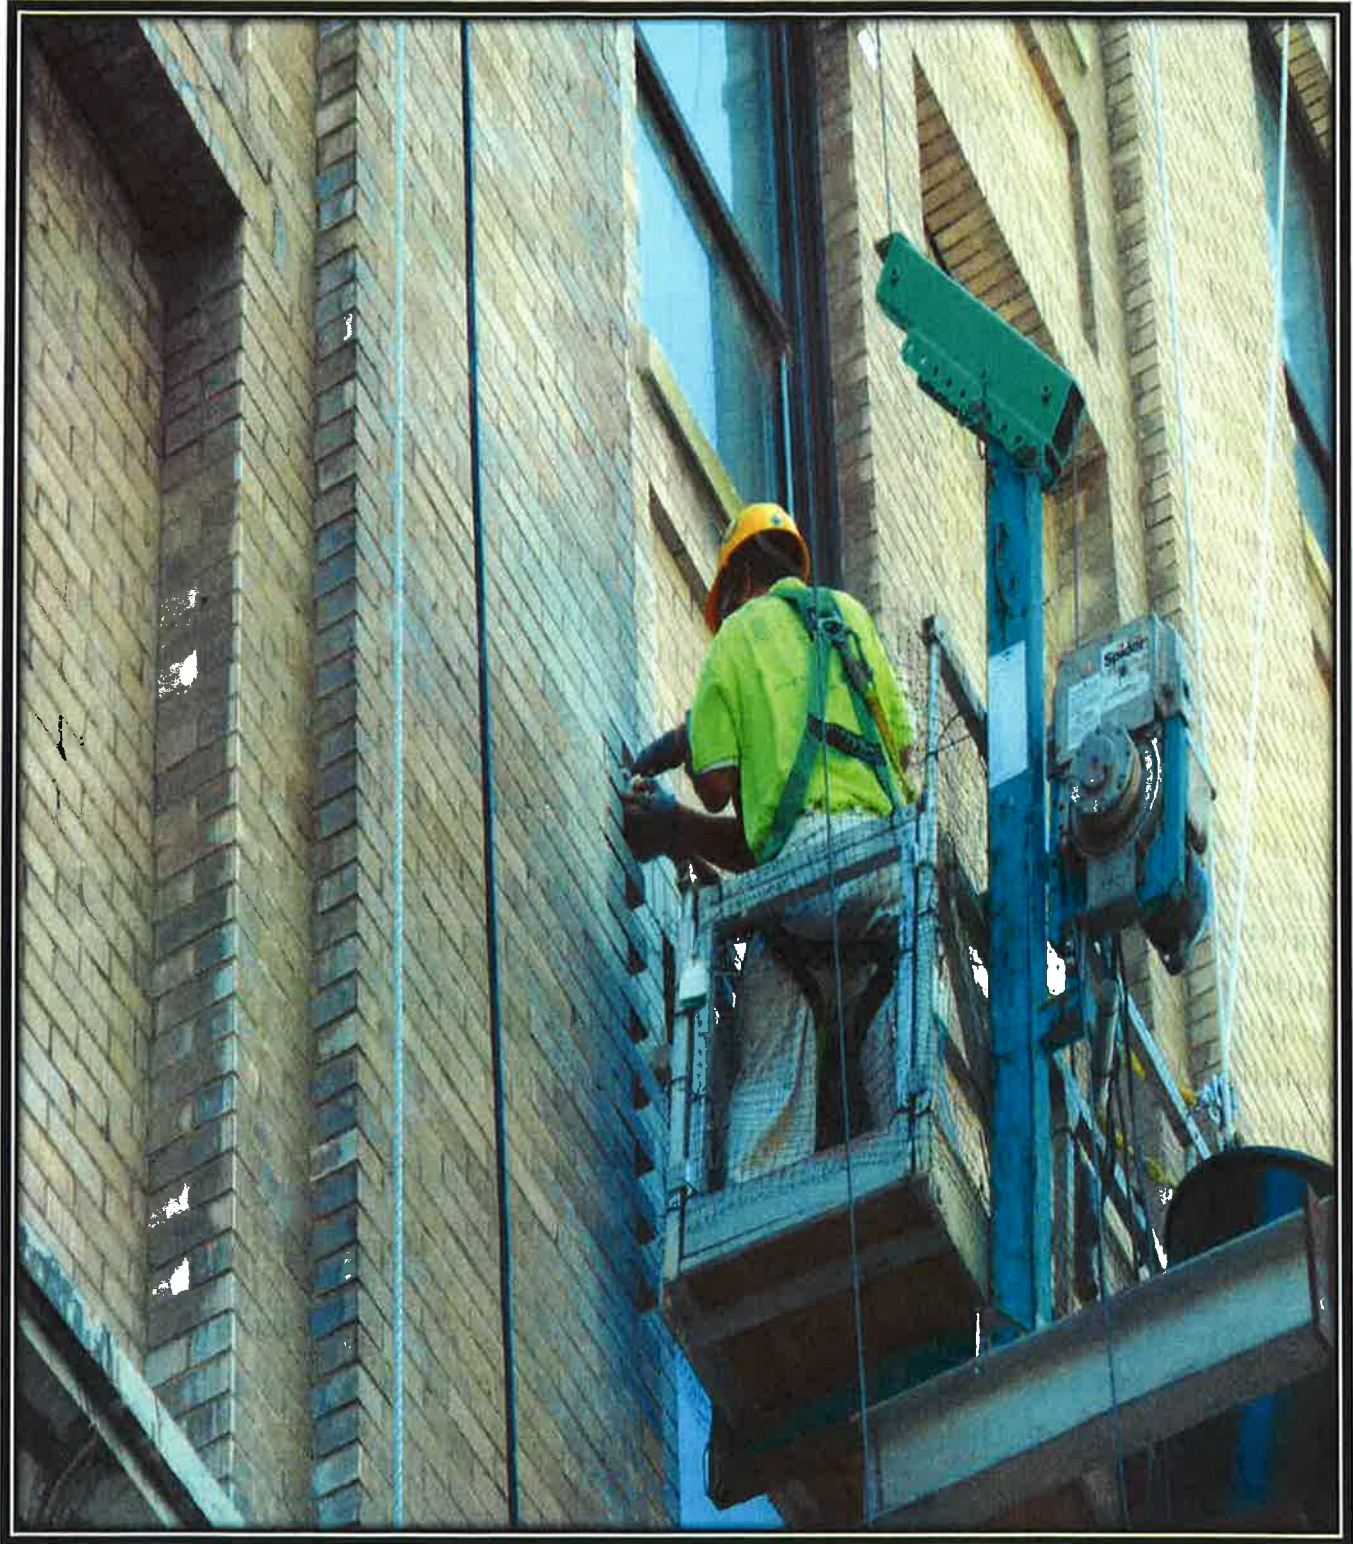
Ongoing brick repairs

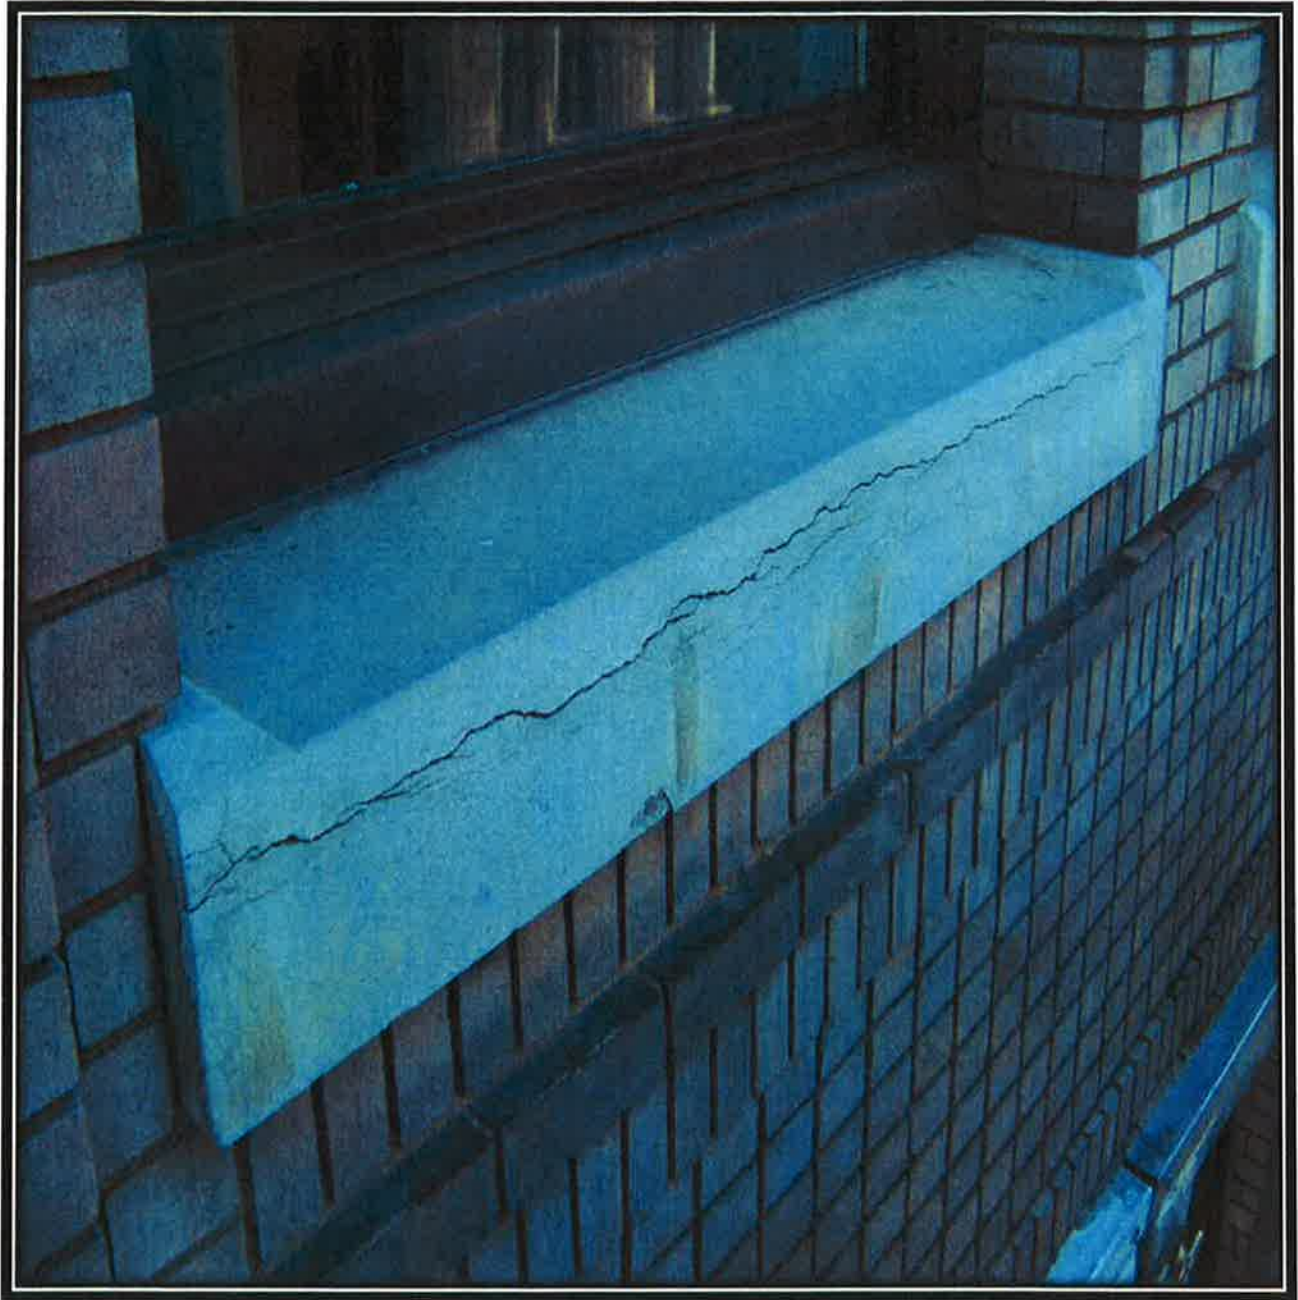
- 1) Varying building tolerances resulting in multi-length stone sills.
- 2) Needs to stabilization of a structurally unsound northeast building corner.
- 3) Difficulty in maintaining harmony amongst employees from two member companies with mildly different policies.

**Cracked window sills to replace with limestone**

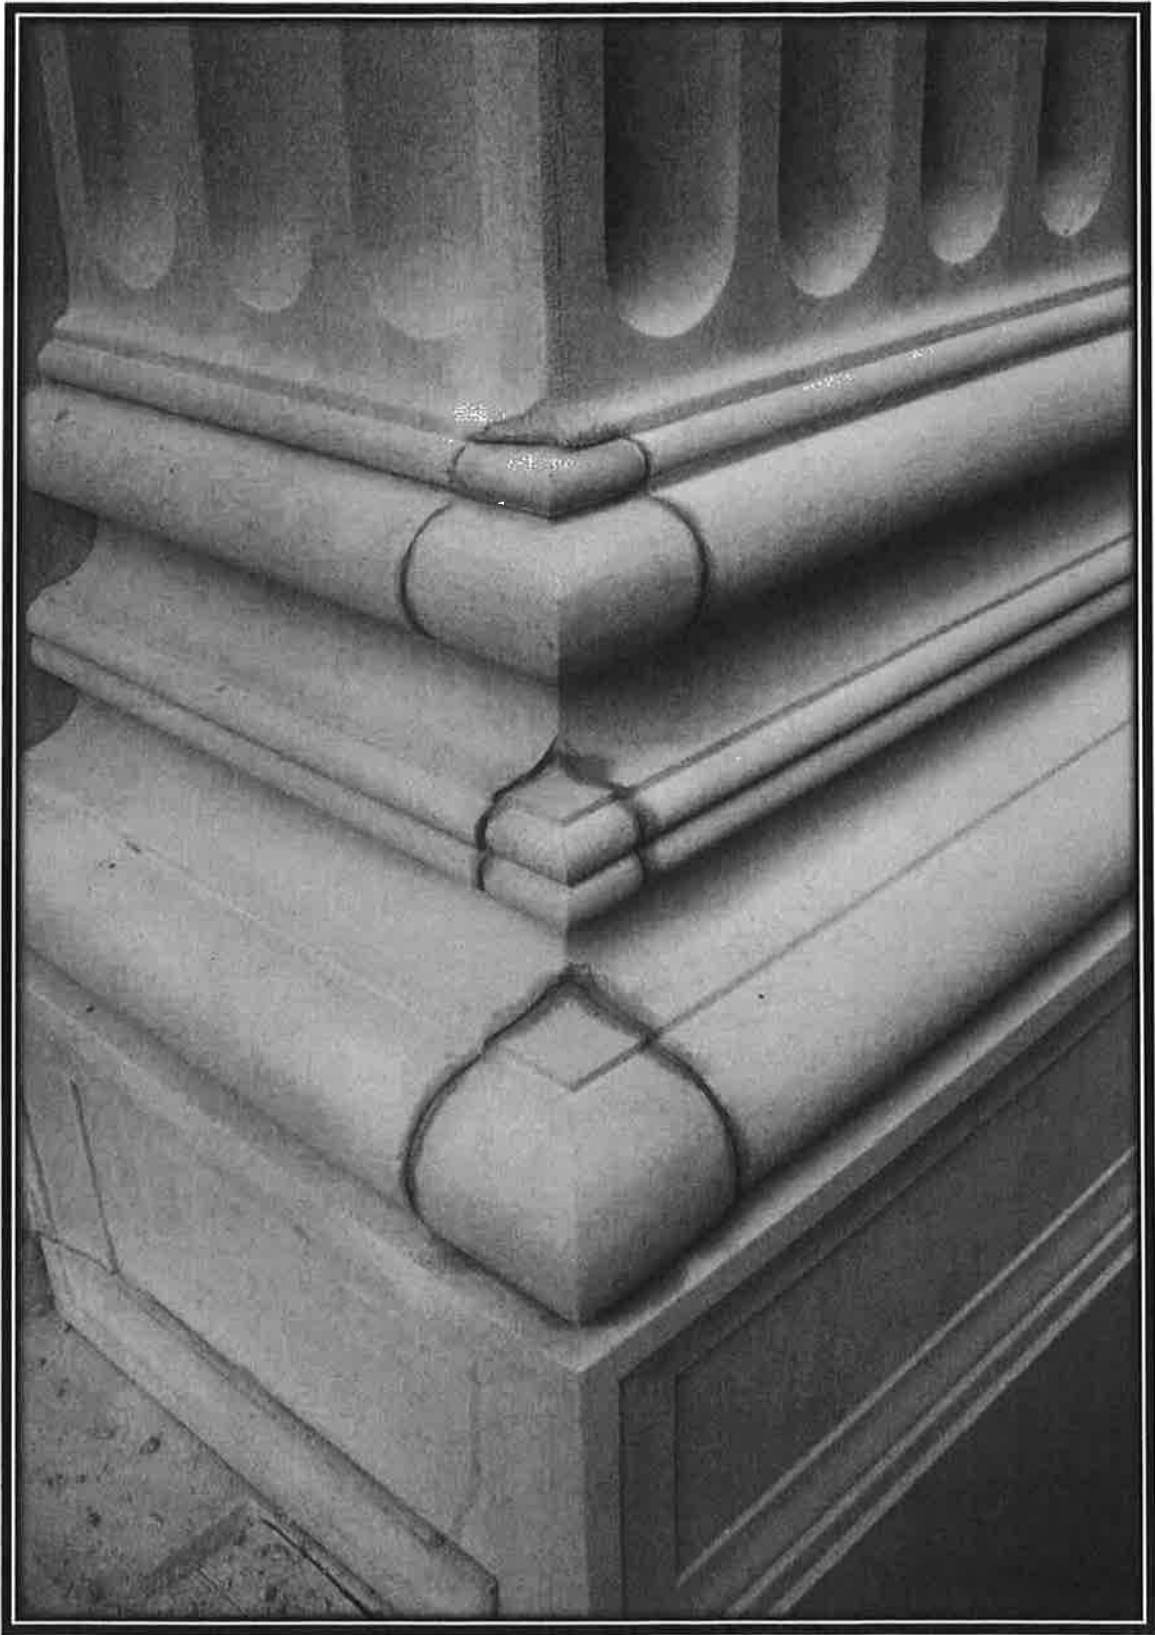
Limestone Dutchman repairs

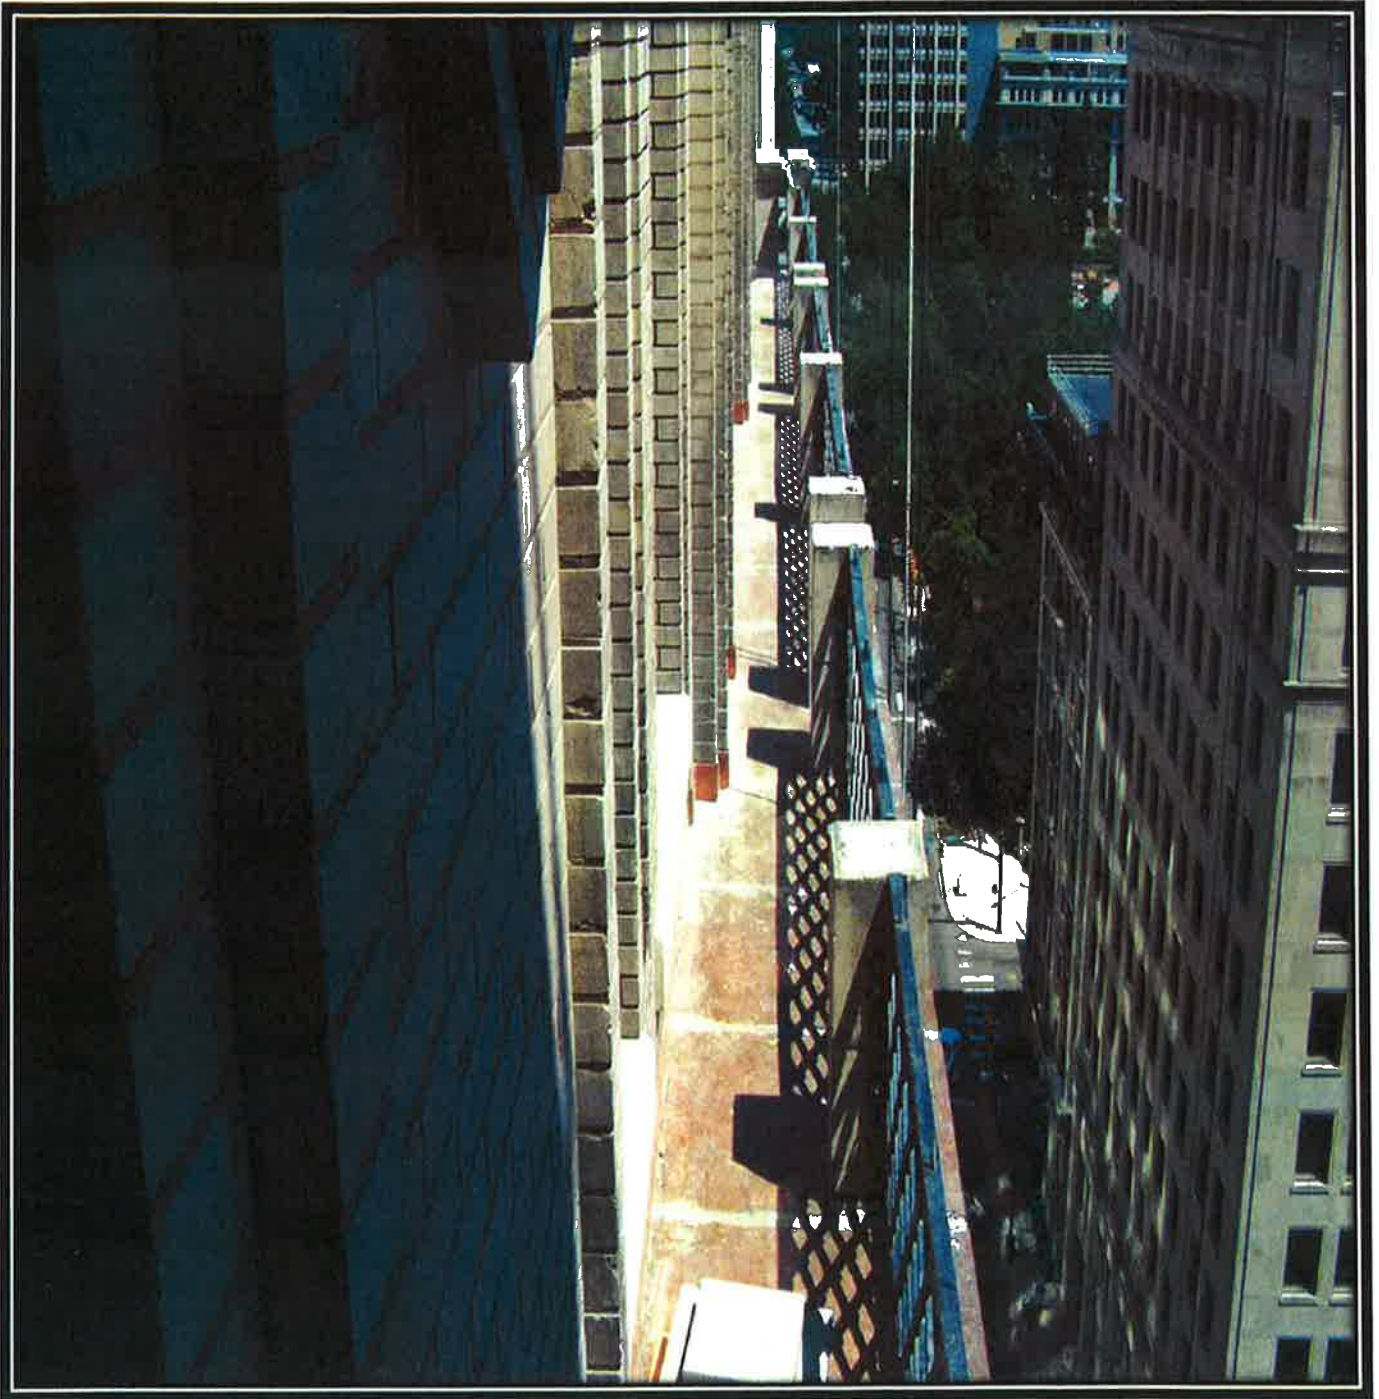
**Upper level balcony reconstruction**

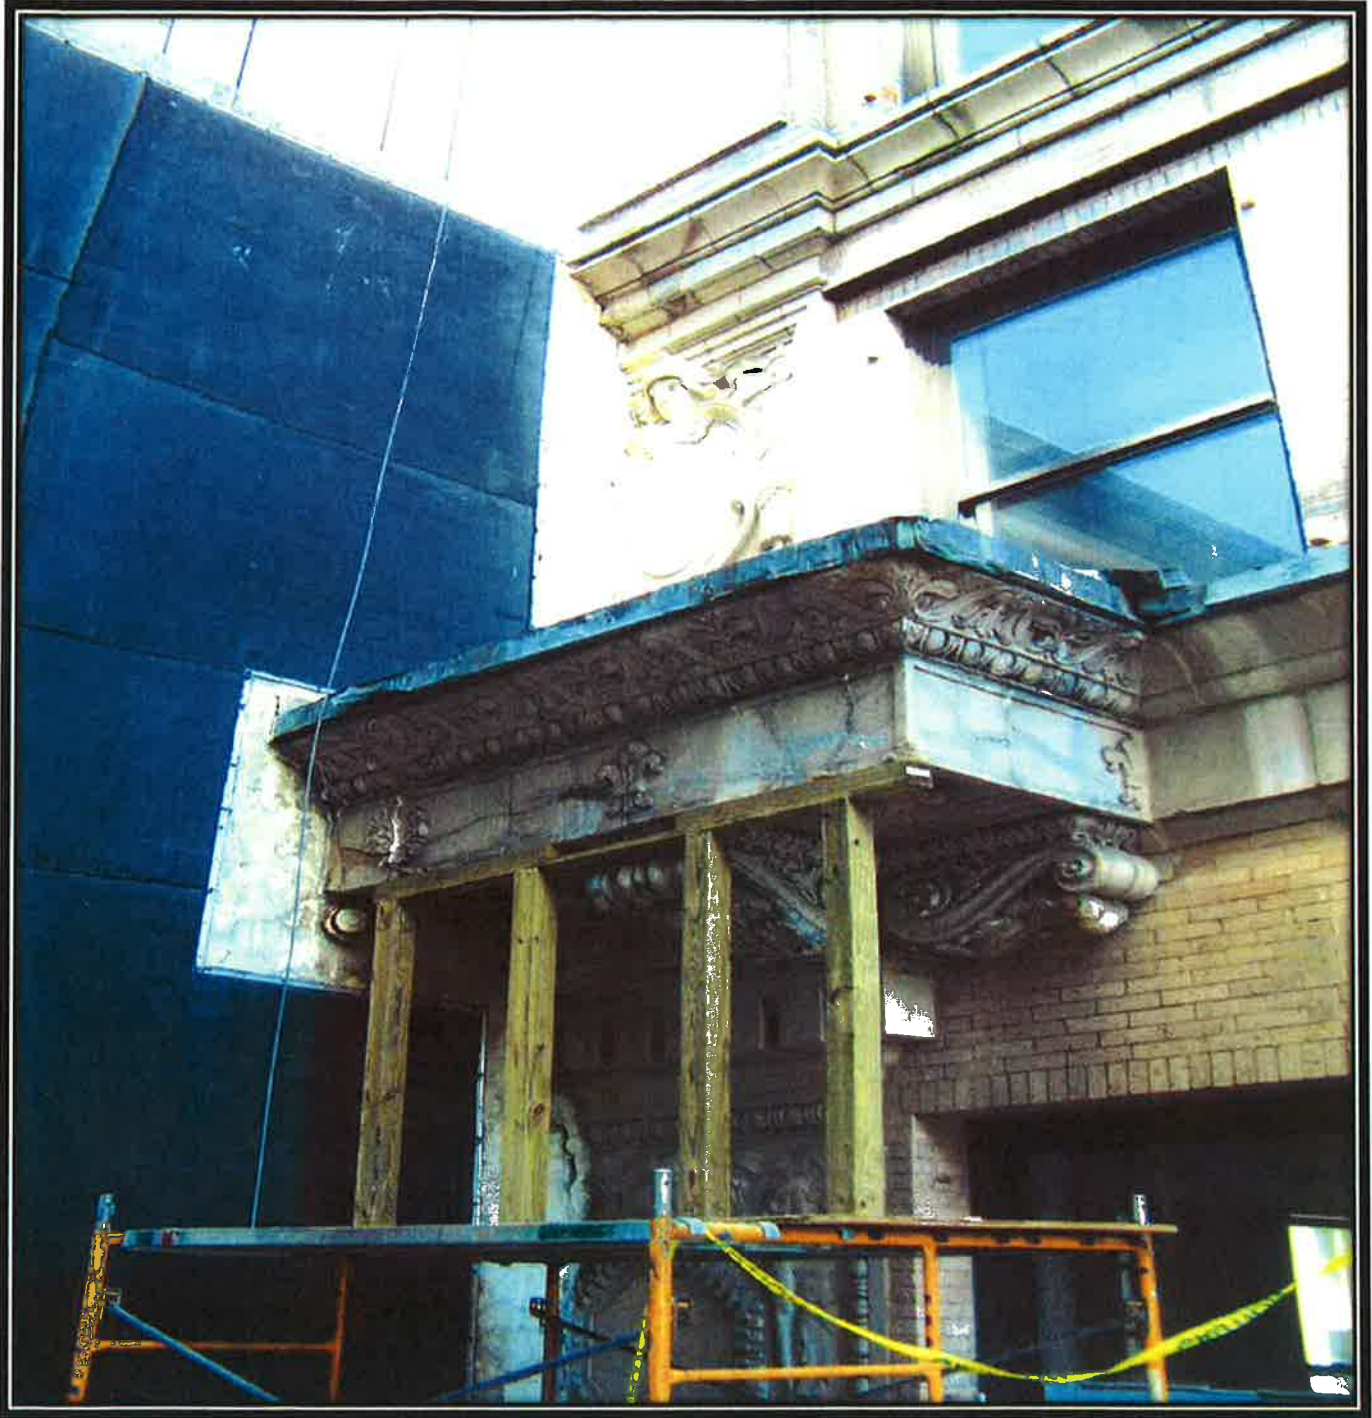
**Northeast corner stabilization needs.**

**Picture depicts existing conditions with temporary shoring prior to placement of netting and full height rod stitching.**

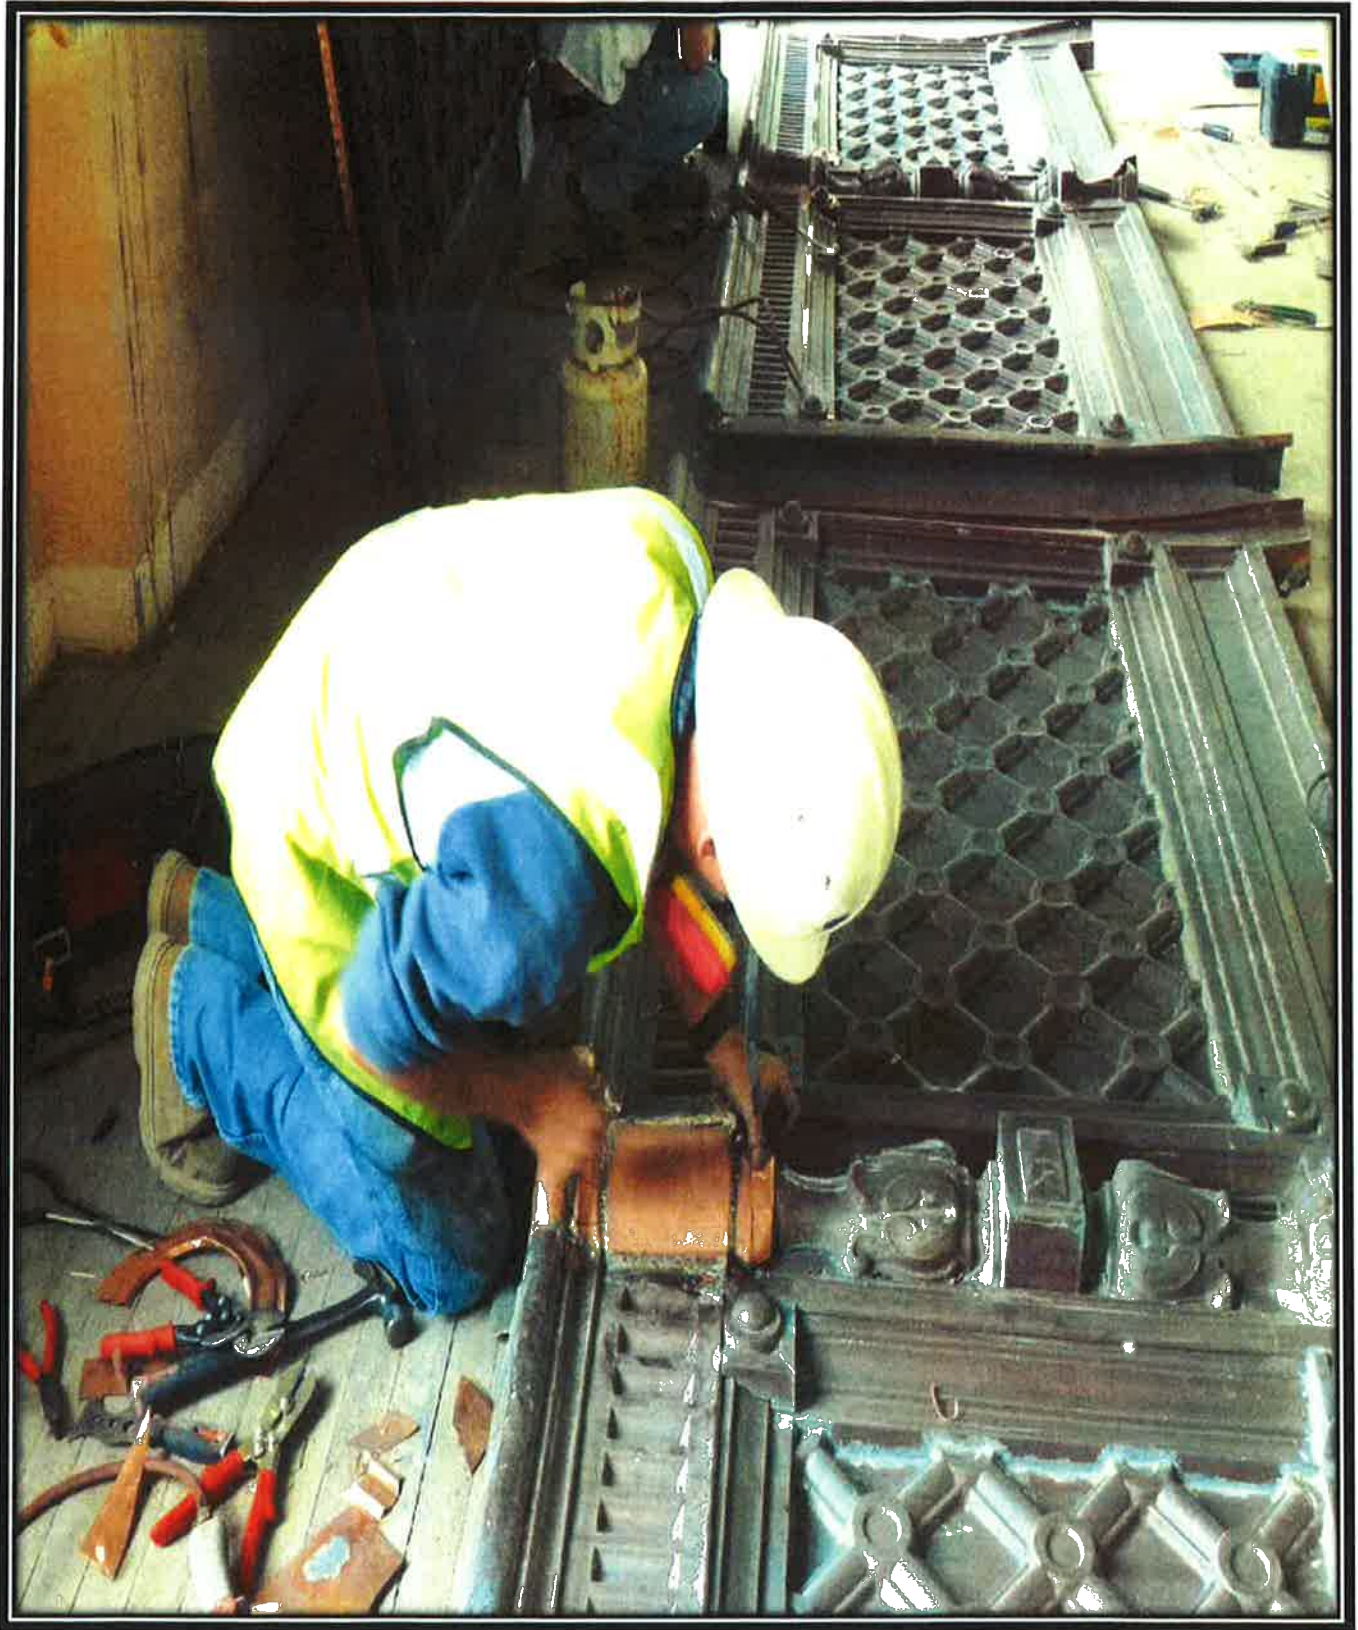
**Maintenance repairs to ornate multi-piece stamped metal panels**

- 2) Sheet metal panel repairs: Handling this puzzle of ornate pieces was mitigated via hiring a roofing vendor possessing an in house specialized metal shop.
