# SWR Institute Trinity Project Awards Program

Project Title: First National Bank - Facade Repairs & Rehabilitation

Location: Richmond, VA

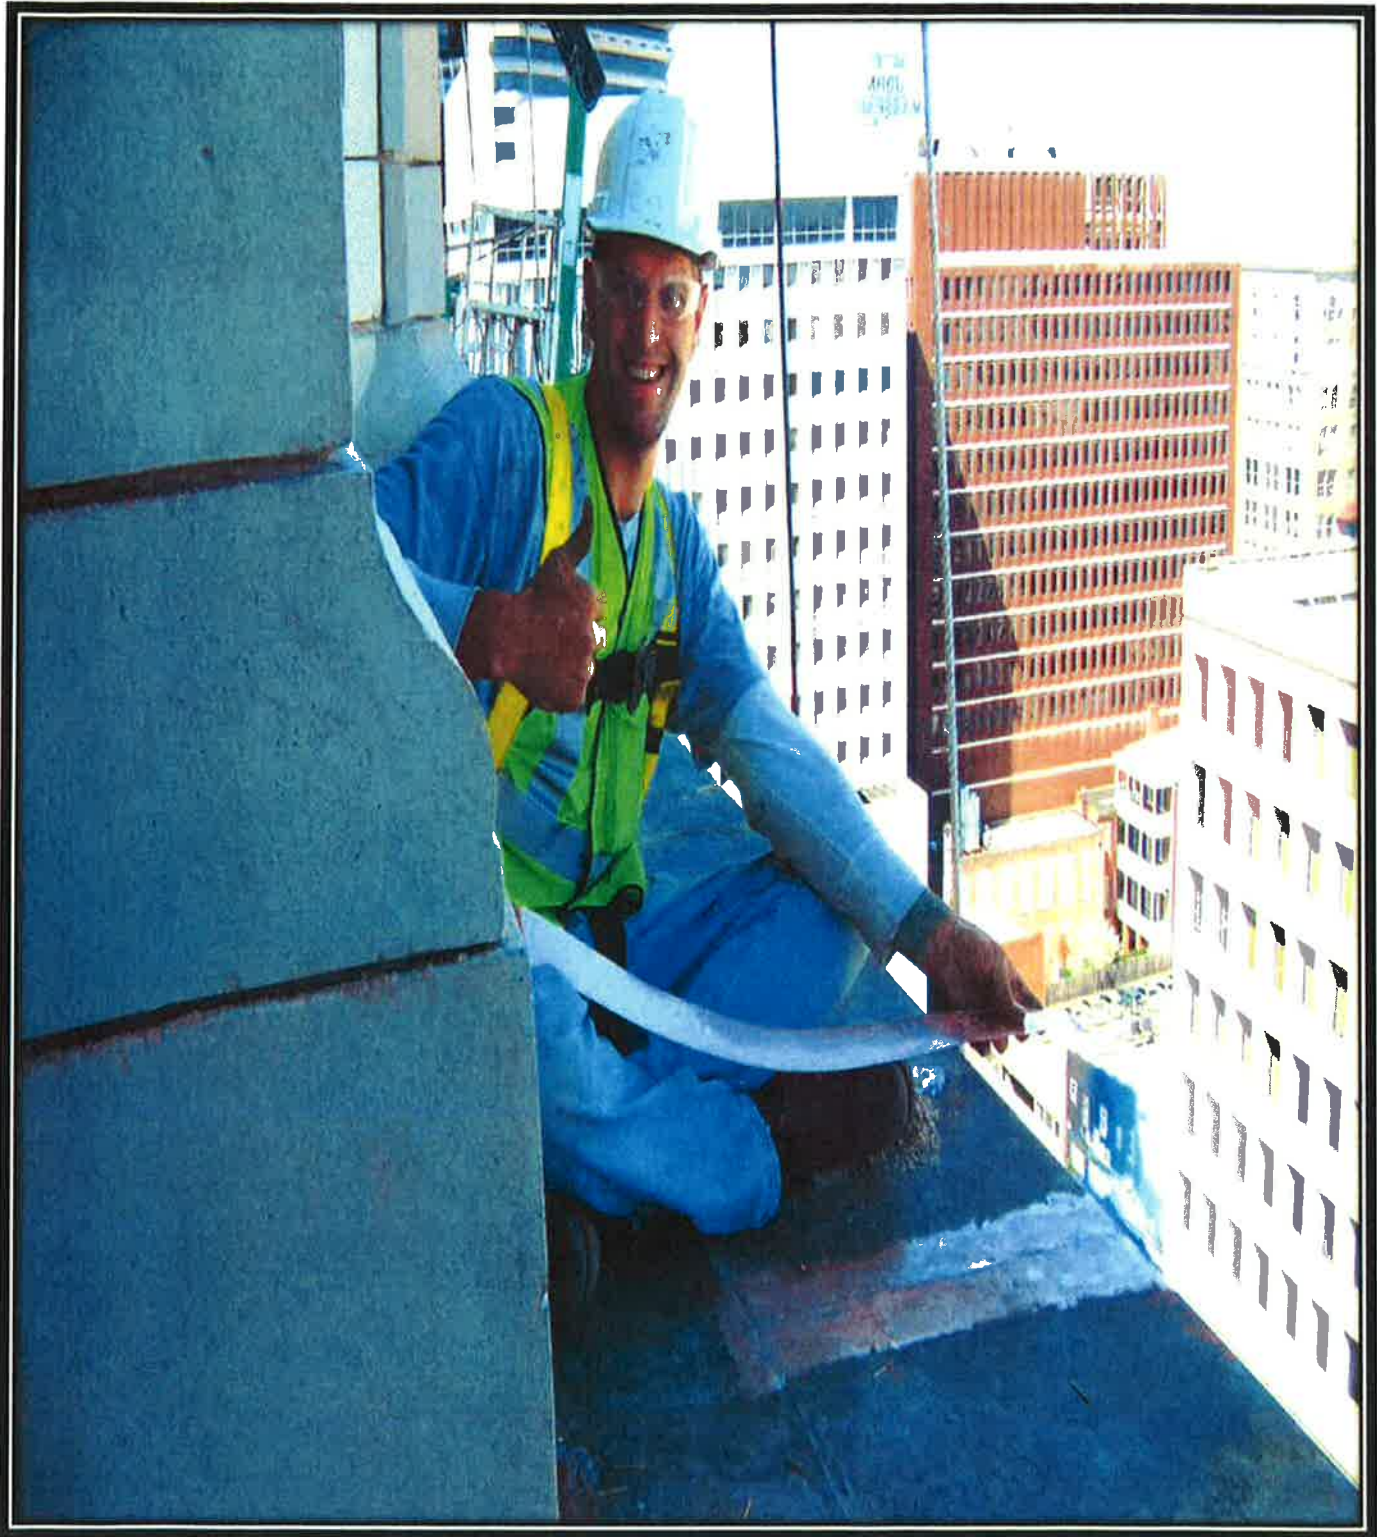
**Sheet metal maintenance**

- 2) Sheet metal panel repairs: Handling this puzzle of ornate pieces was mitigated via hiring a roofing vendor possessing an in house specialized metal shop.
