**Bellaire Tower**  
**San Francisco, CA**

## ABSTRACT:

Bellaire Tower, San Francisco, CA, was built in 1930. The Art Deco building is a high profile, historic building with extensive ornamentation and details. Logistics were unique: interior enclosures were built to protect residents during construction, swing stages were used on the windiest corner in San Francisco. Containment of lead paint during removal process required careful consideration (20 stories high in a densely populated residential area with winds often as high as 90 mph). A very large mock-up was completed 2 years ahead of the project that enabled the Team to better understand the problems and to plan the project.

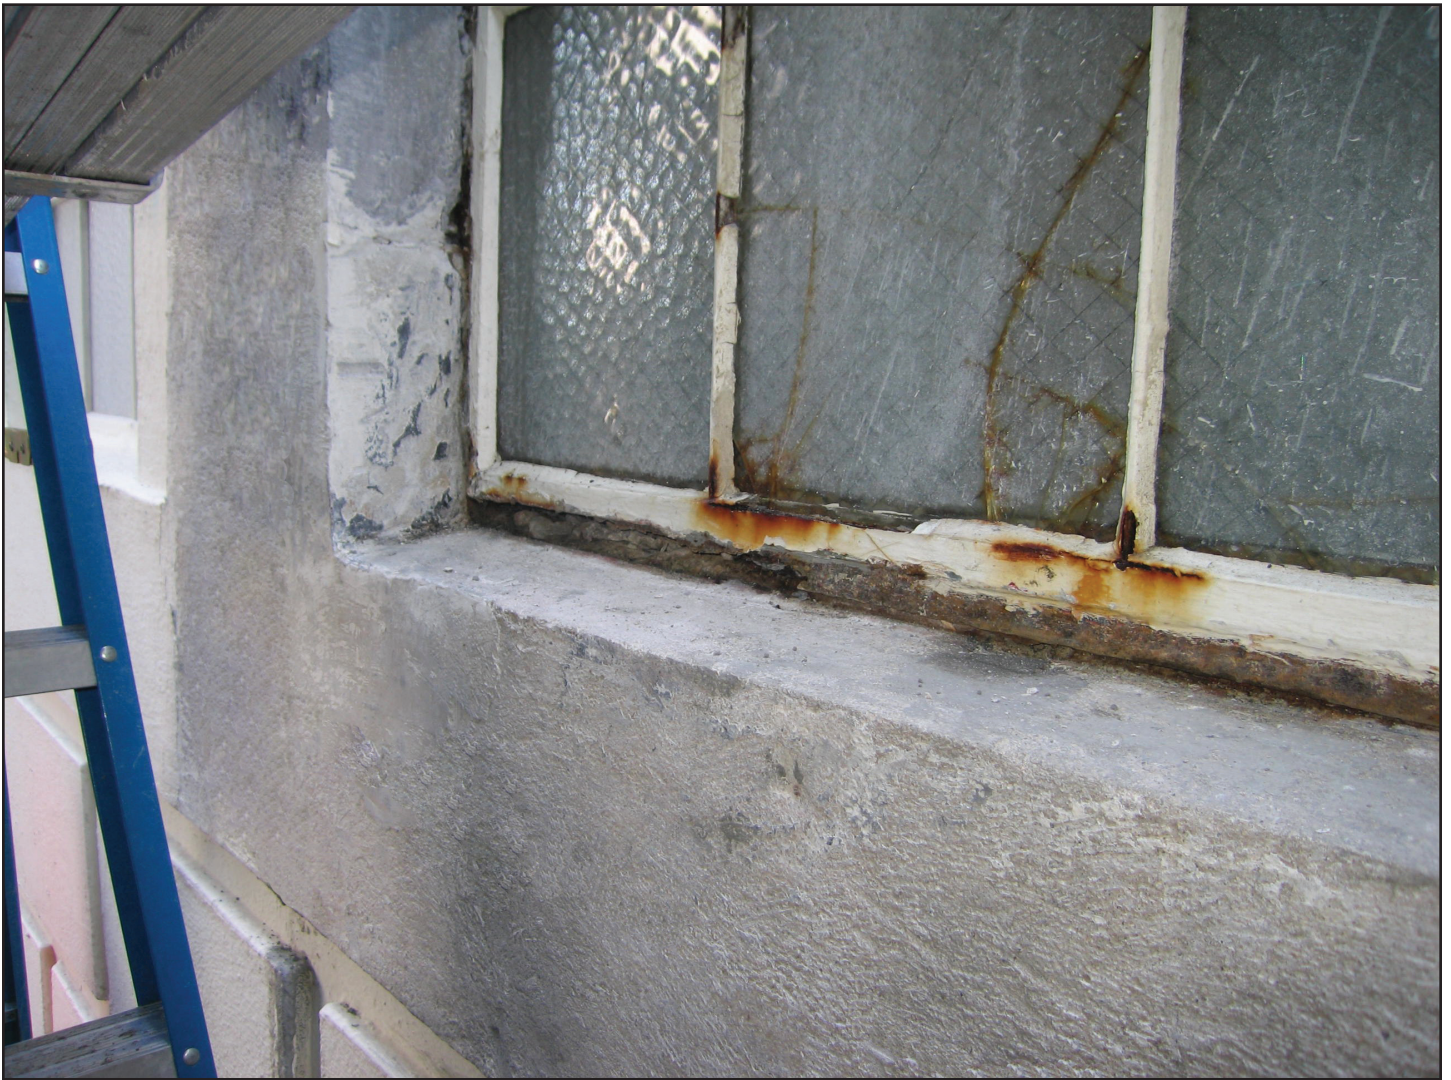
An old window showing signs of its age.

Window refurbishment was tedious and labor intensive. All work was done by hand. Work proceeded as originally planned for the south and west walls. Because the fire code restriction did not apply to the north and east elevations, the Team had greater flexibility on how to treat the windows. Windows were either refurbished or replaced depending on cost effectiveness. Approximately 25% of the steel windows were replaced. Additionally, all metal-metal and metal-glass in the aluminum windows received a new wet seal of silicone. In total, 80 steel windows were replaced, another 360 were refurbished; while about 100 aluminum windows received new wet seals throughout and another 100 received a new wet seal around the perimeter.

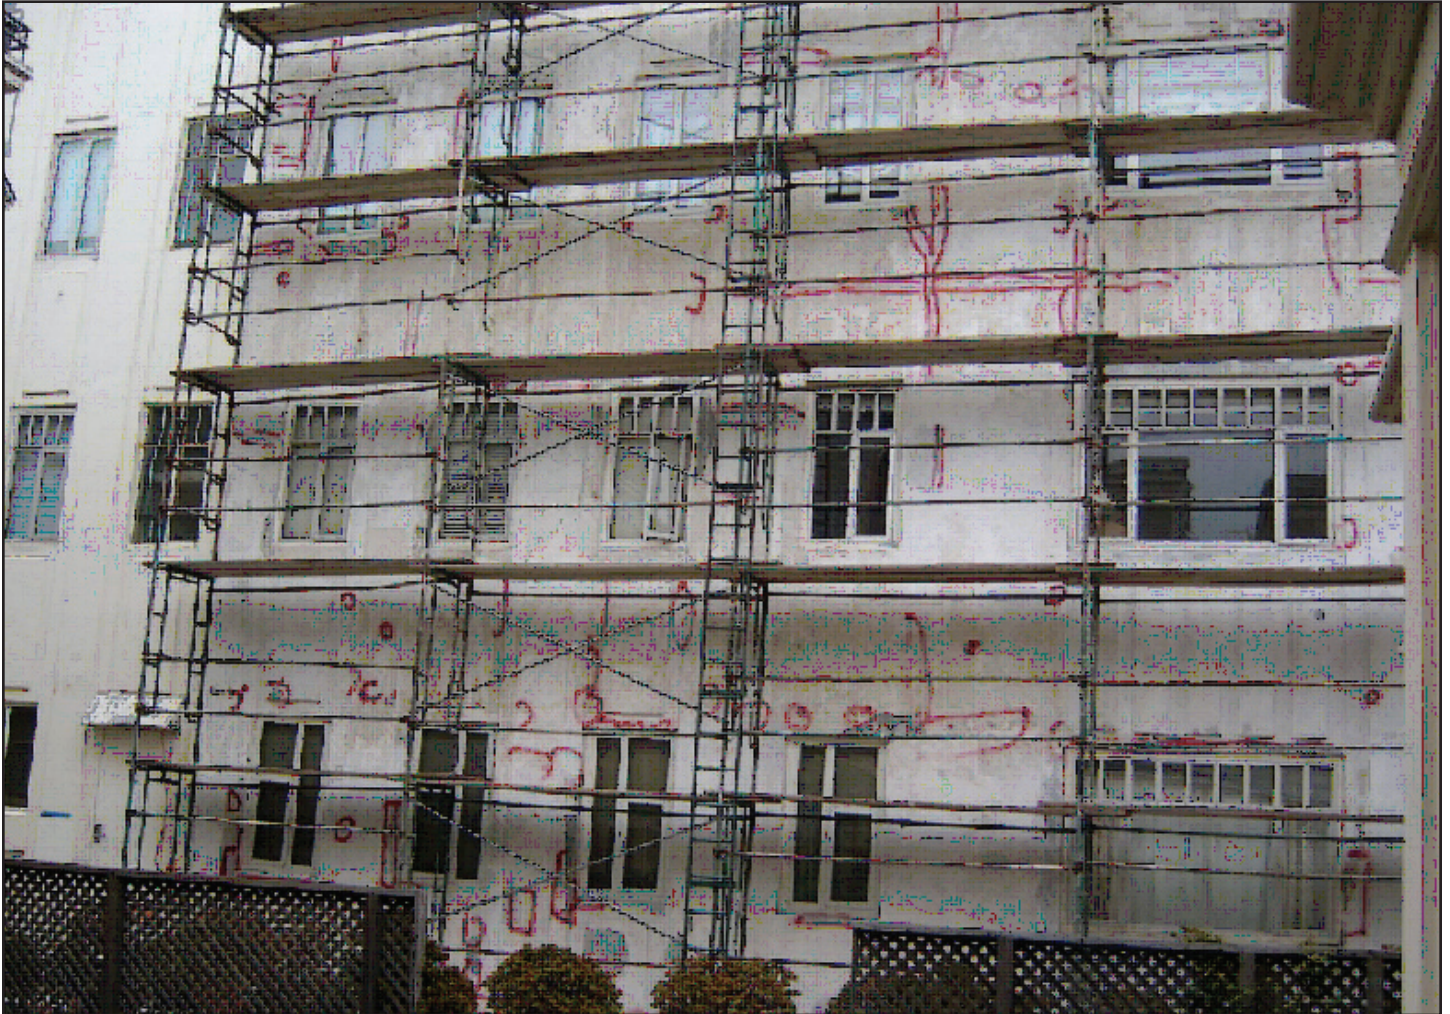
Mock-up phase, coating removed and delamination and cracks identified.

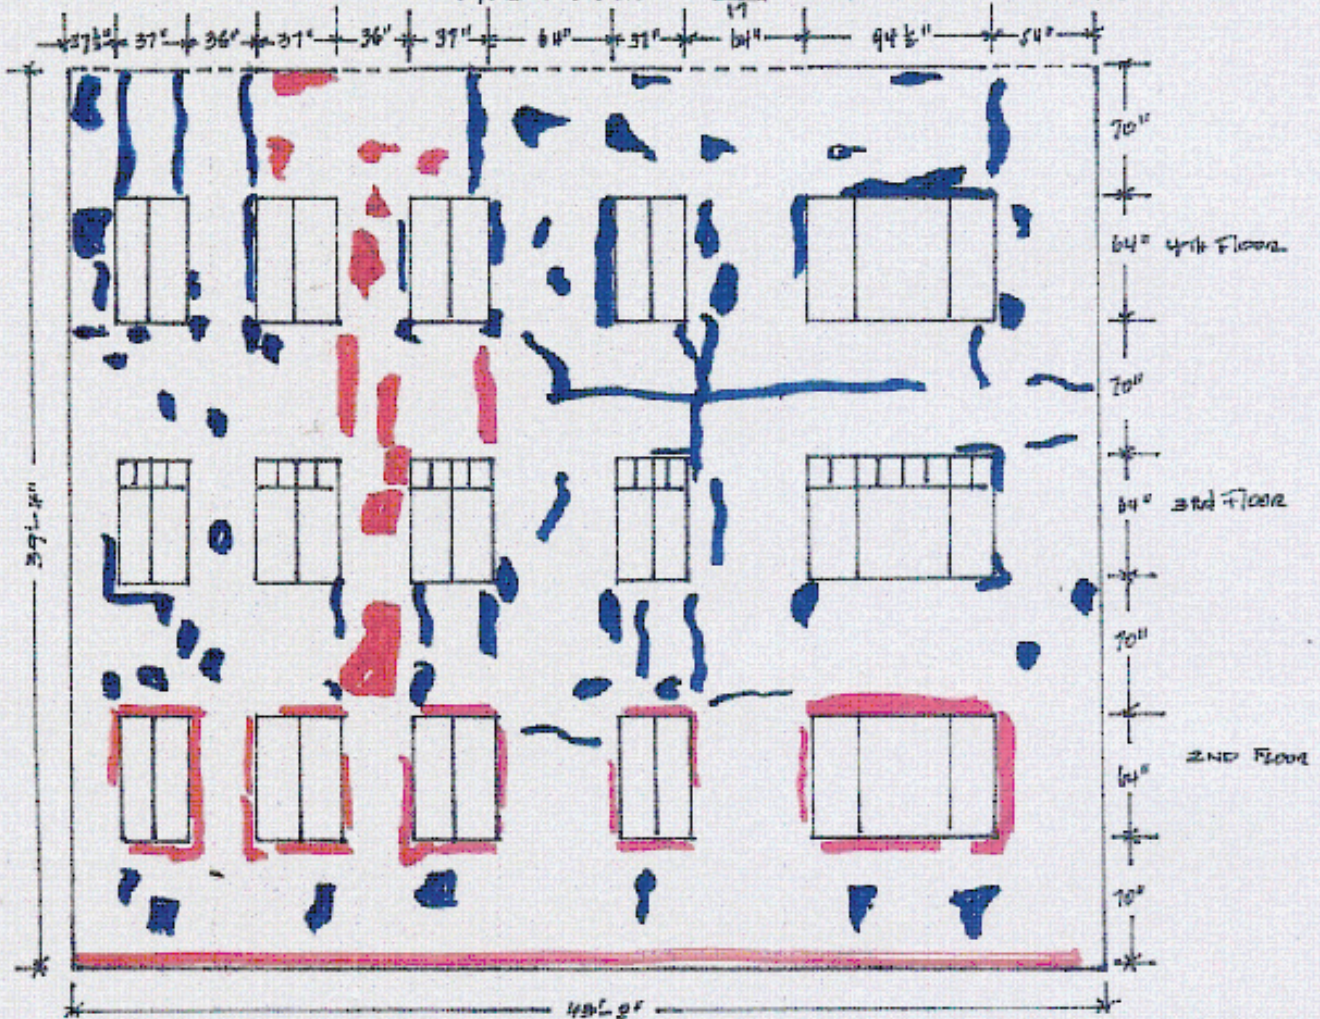
CONCRETE REPAIRS RATIO FOR THE MOCK-UP

TOTAL MOCK-UP SURFACE 43'-8" X 37'-4" = 1,713.43 S.F. OR 1700 S.F. (ROUNDED UP)

FOR BUDGET ESTIMATING: TYPE A SPALLS =  $\frac{51}{17} = 3$  LOCATIONS PER 100 S.F.  
 CRACKS =  $\frac{60}{19} = 3 \frac{1}{2}$  LF PER 100 S.F.  
 TYPE B SPALLS =  $\frac{73}{19} = 4.6$  LOCATIONS PER 100 S.F.

- = TYPE A SPALLS X  $\frac{3}{4}$ " = 51 LOCATIONS
  - = CRACKS = 60 LINEAL FEET
  - = MASON SPALLS +  $\frac{3}{4}$ " BASE = 34 LOCATIONS + 43'-8" AT BASE OF ELEVATION
- = 44 S/F OR LOC.  
 73 TYPE B SPALLS

Mock-up phase, defects transferred to a drawing for record keeping.  
 Note approval of repairs.

REPAIRS APPROVED 11-17-04

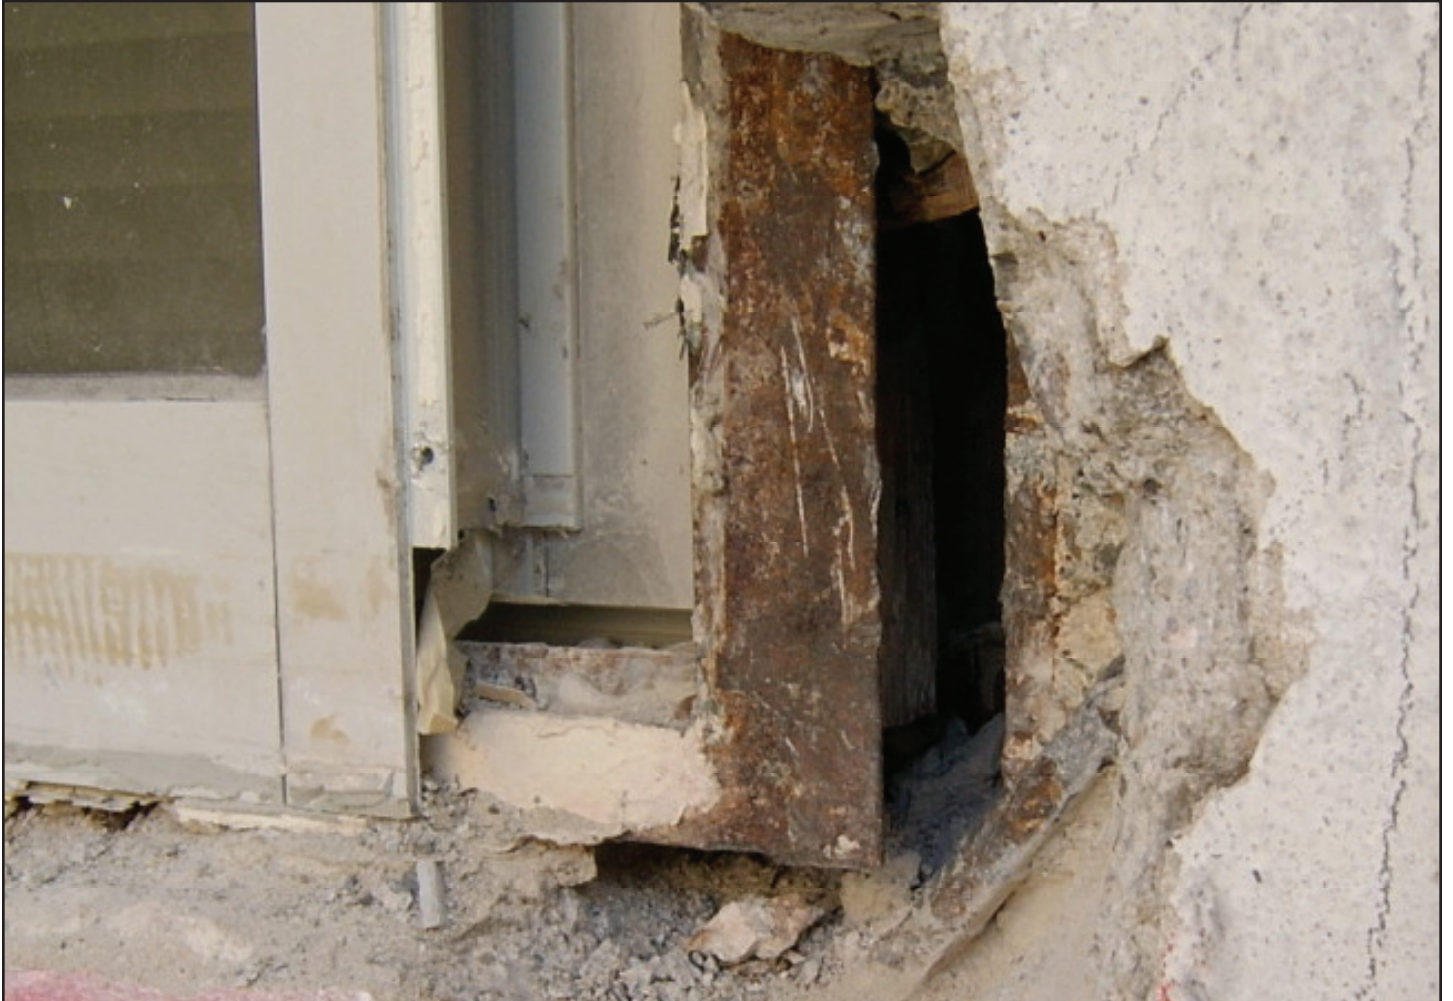
**Good example of spalling caused by the window steel flange corrosion.**

3,500 anodes were placed and grouted into cored holes and connected to the steel window flanges. Other anodes were tied directly to the reinforcing steel. In some of the tighter areas a zinc coated sheet was applied to the steel flange. Steel coatings were brushed onto the exposed reinforcing steel and steel window flanges. Window perimeter concrete repair (1,500 LF) was formed on 2 sides and poured into place. Other concrete repairs (2,000 SF) were hand-applied.

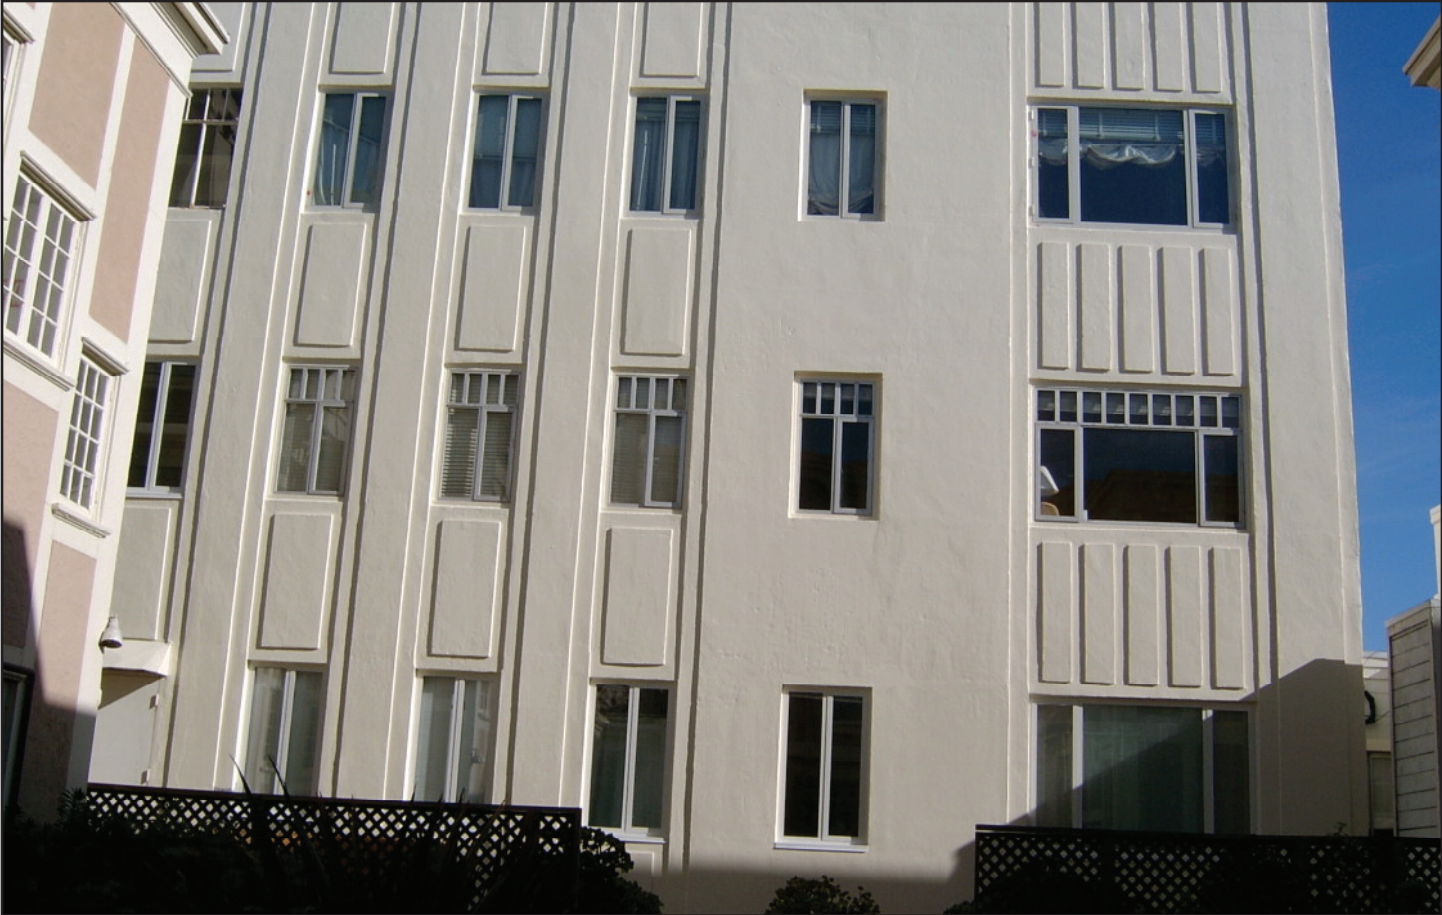
Completed mock-up.

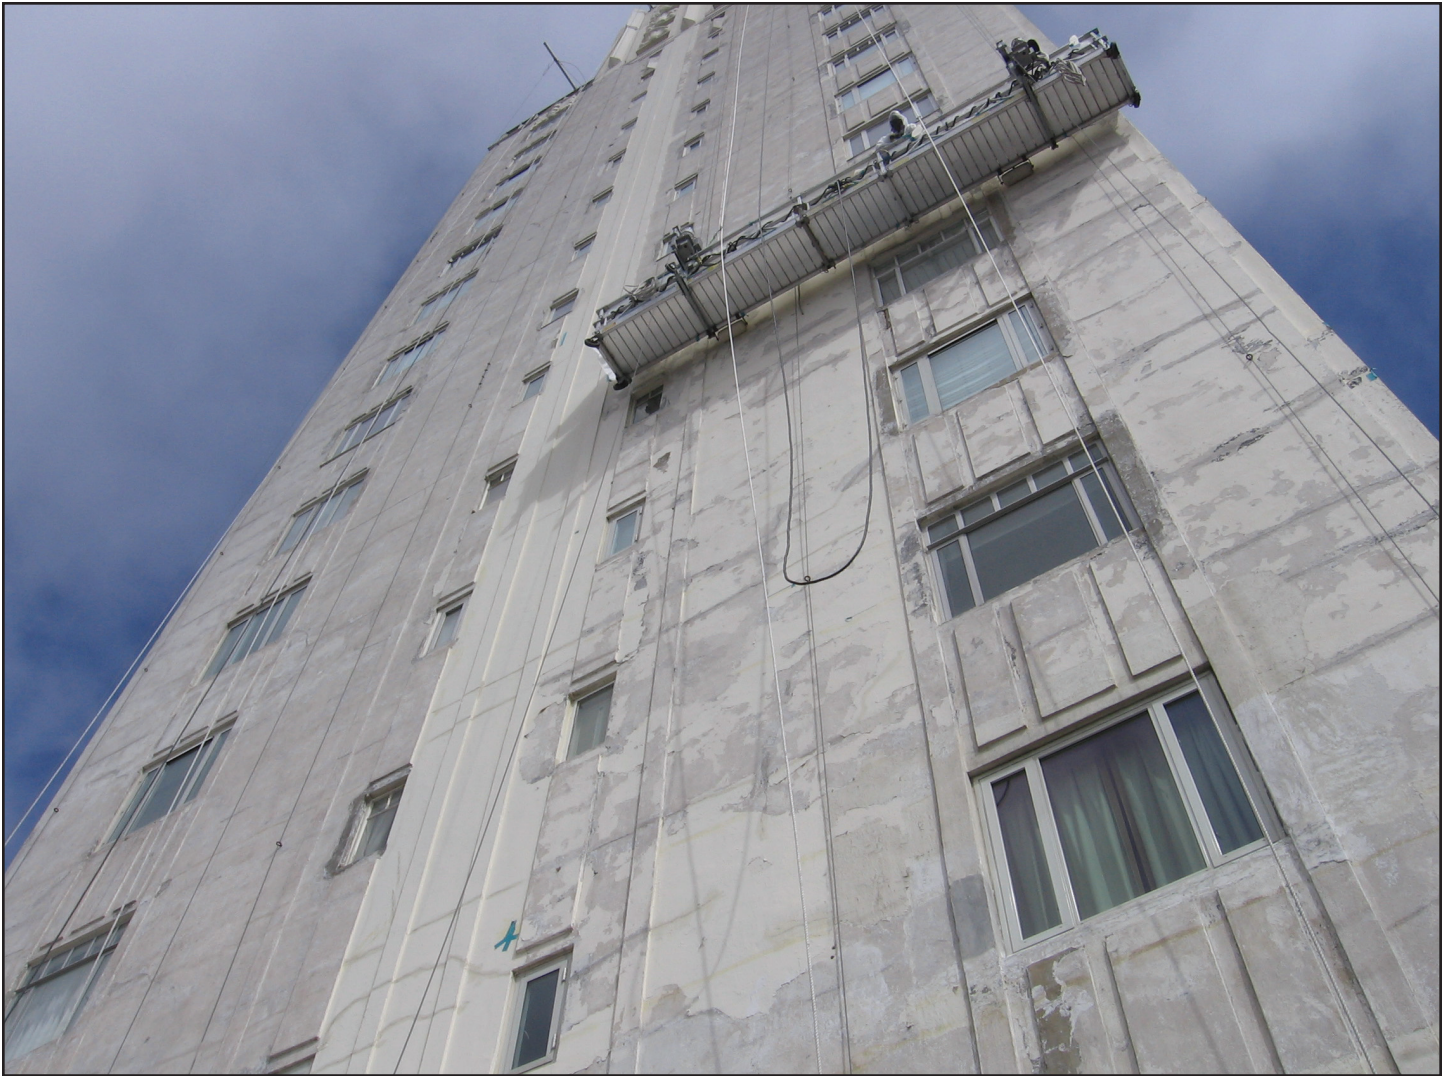
**Coating removal required several passes using different methods to complete.**

The primary problem was water leakage in and around the windows as well as spalling of the concrete. The building was recoated numerous times resulting in the accumulation of over 90 mils of non-breathable coating(s) over the concrete. The solution was removal and abatement of the coatings (some coatings contained lead), concrete and crack repair and complete window restoration and replacement.

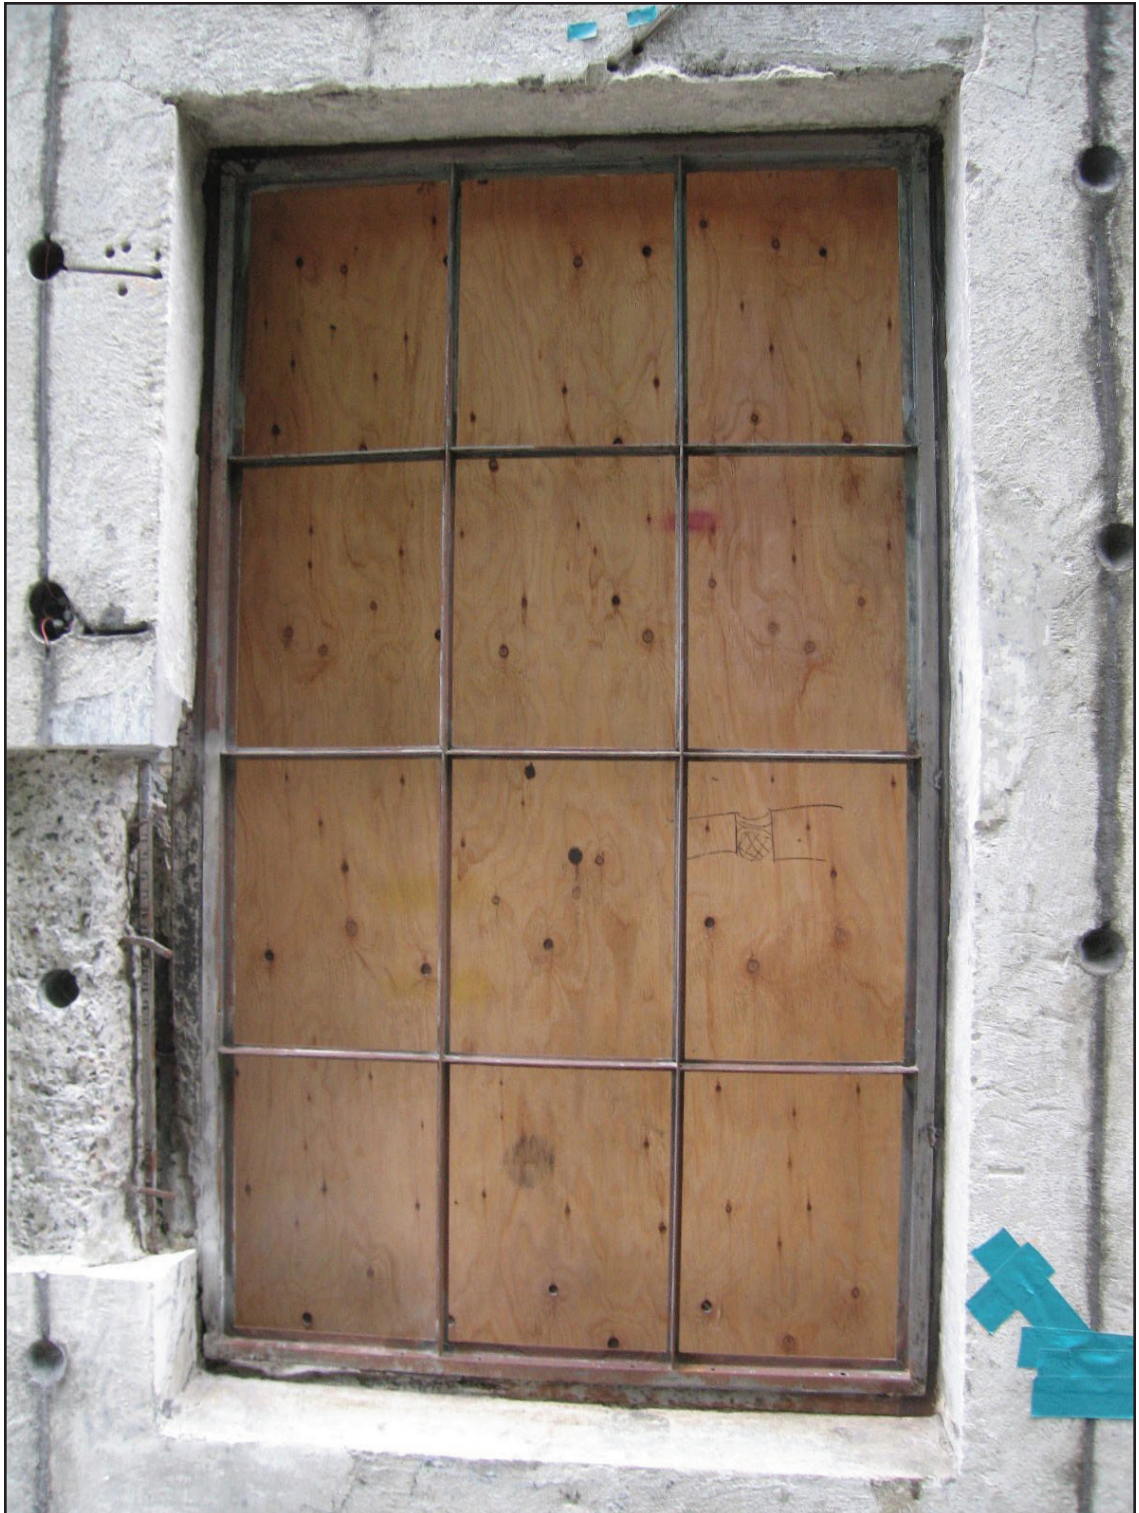
Areas to be repaired were cleaned and rinsed. Joints were wiped clean for the new sealant. Ahead of applying the coating, the exterior wall was powerwashed.

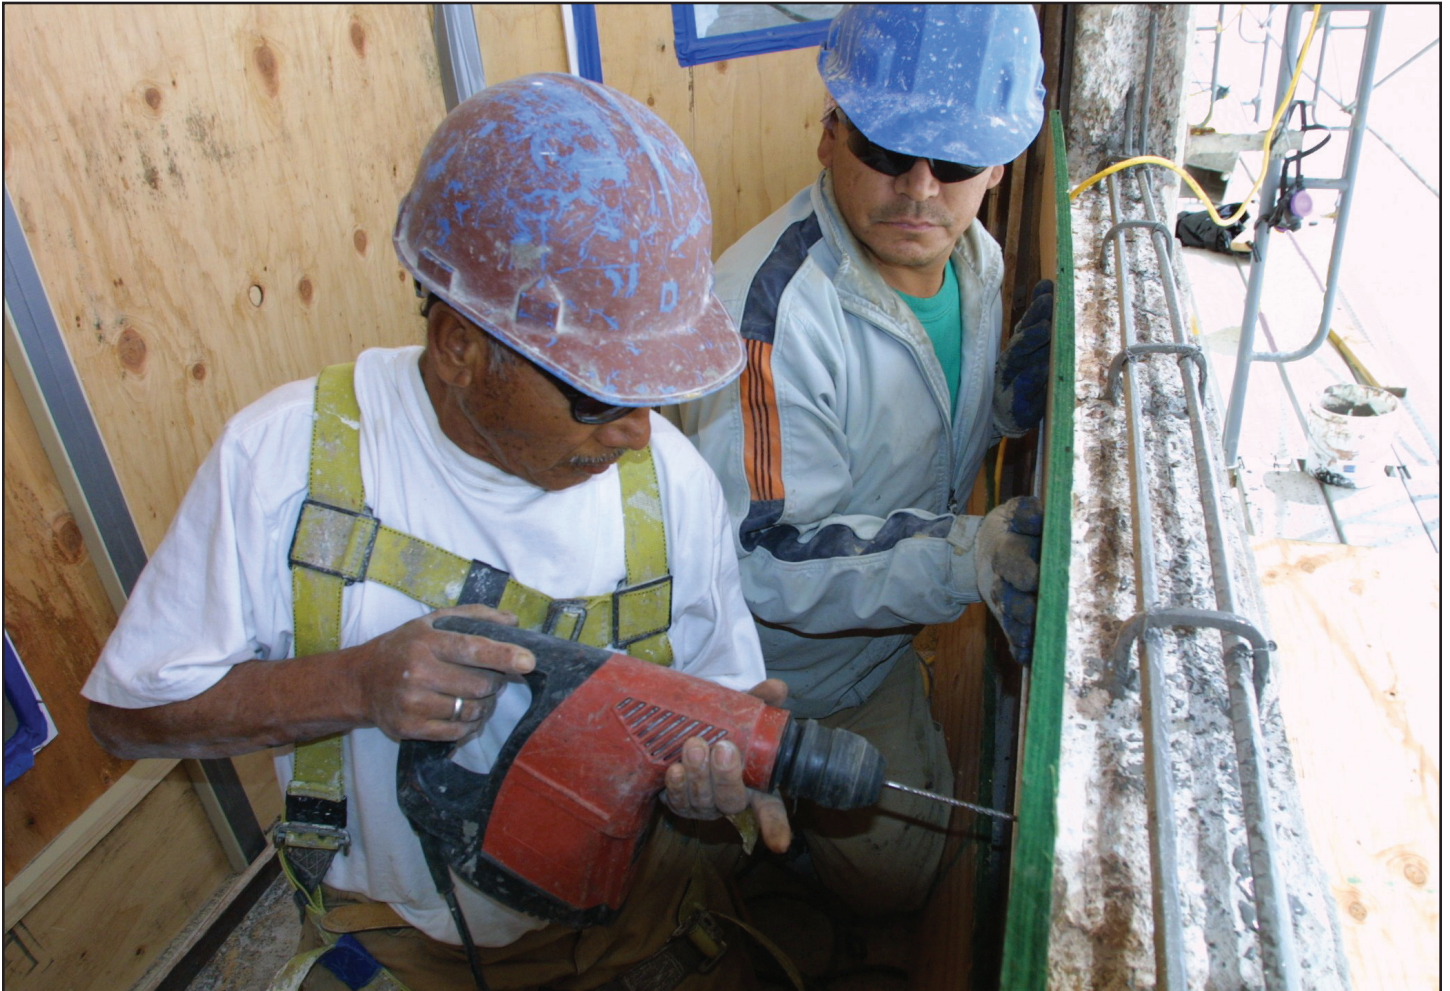
**Workers rebuilding a window sill.**

**Note the workers are standing inside a condominium unit with protection in the background.**

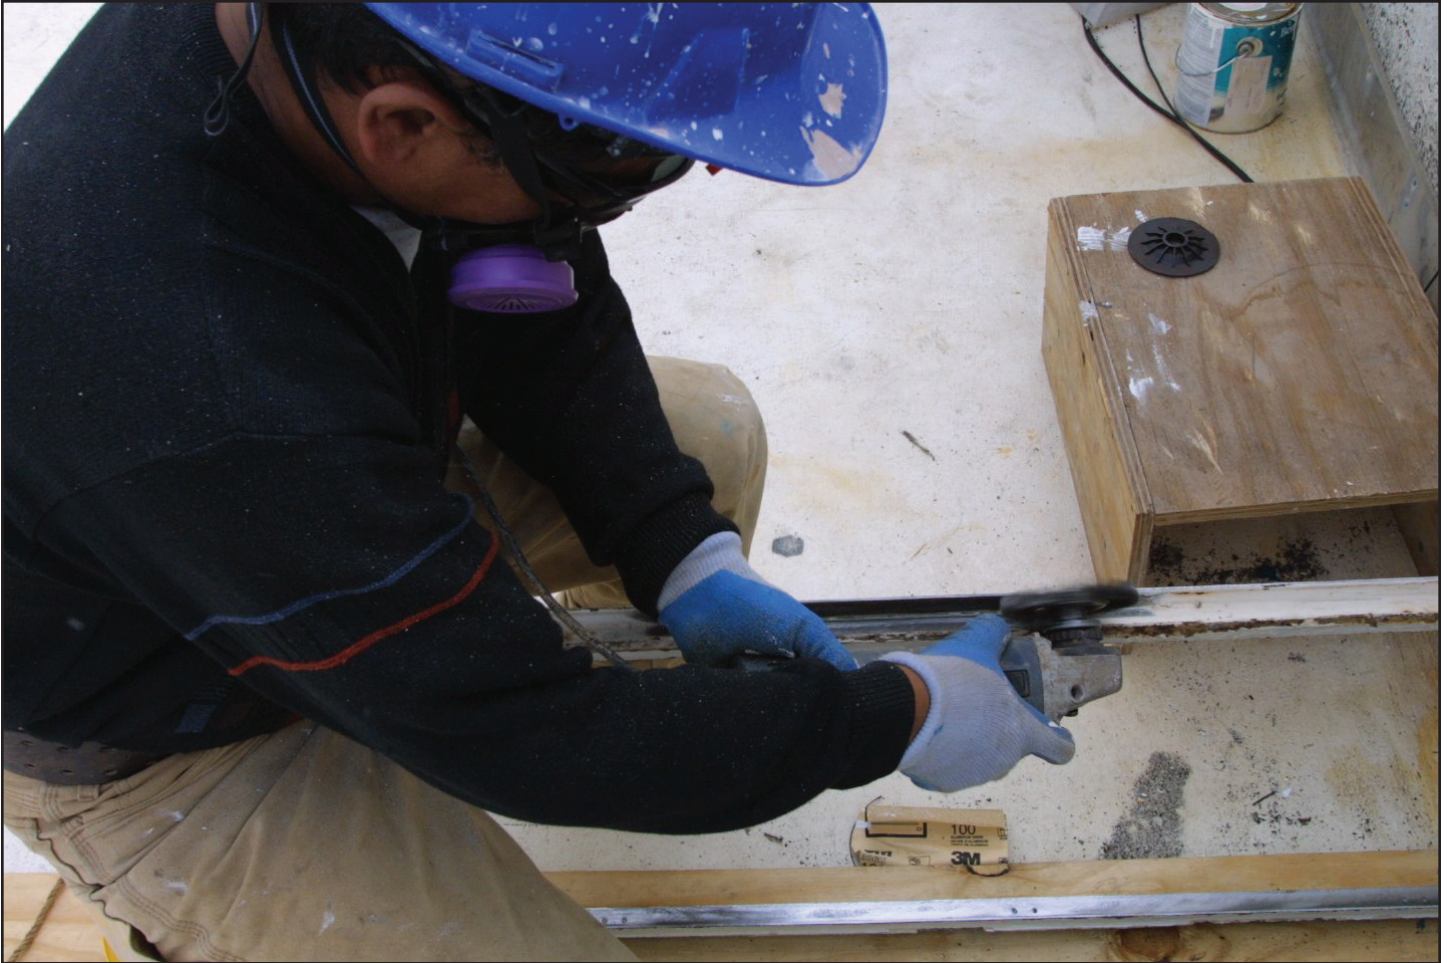
**Window refurbishment was tedious and labor intensive.  
Example of the work required to restore the windows.**

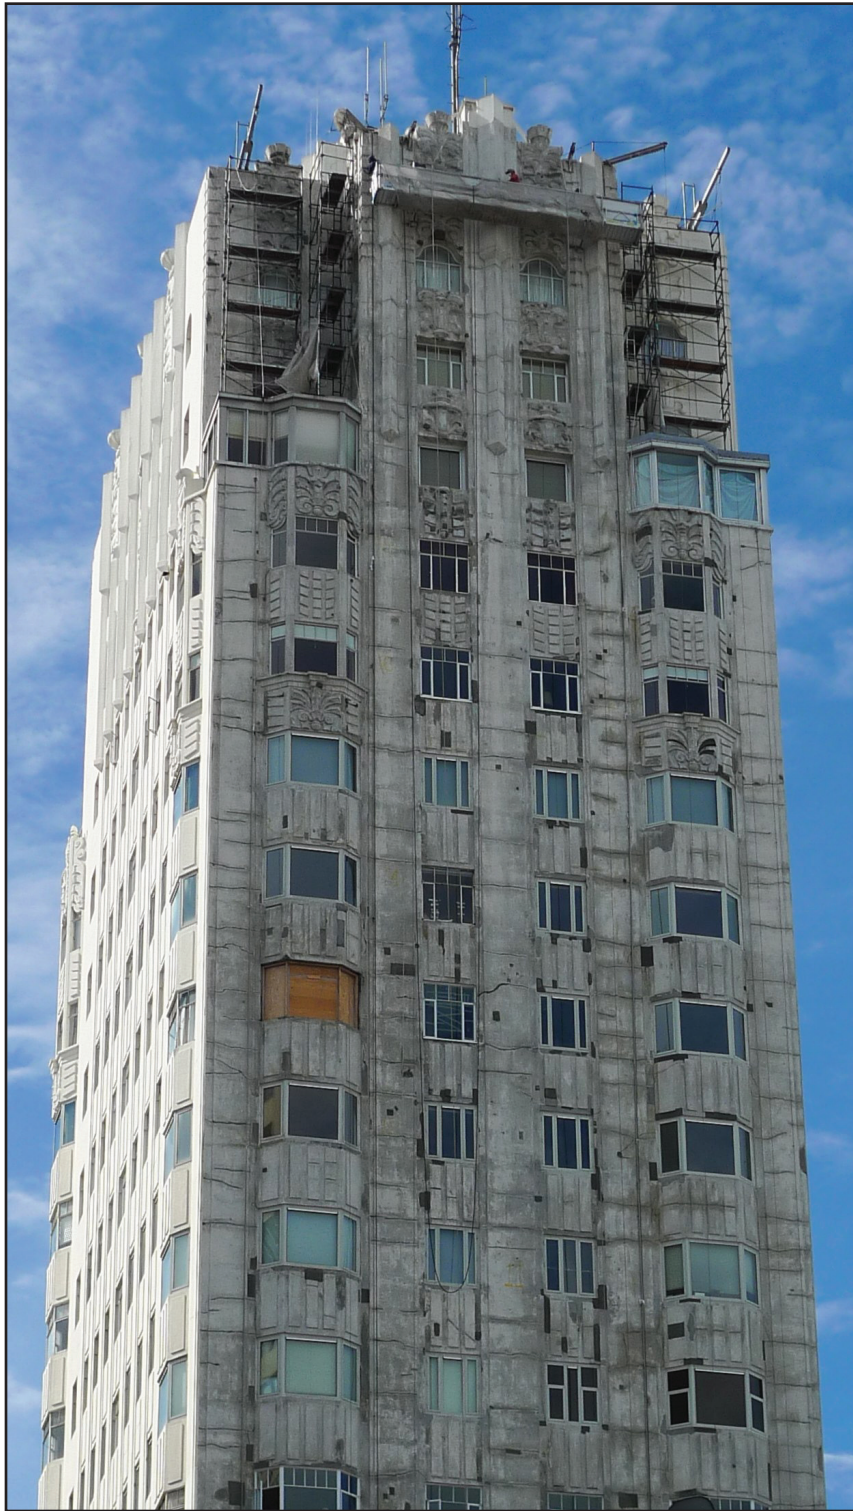
North facade: 1. coating removed, 2. Crack and concrete repair in progress

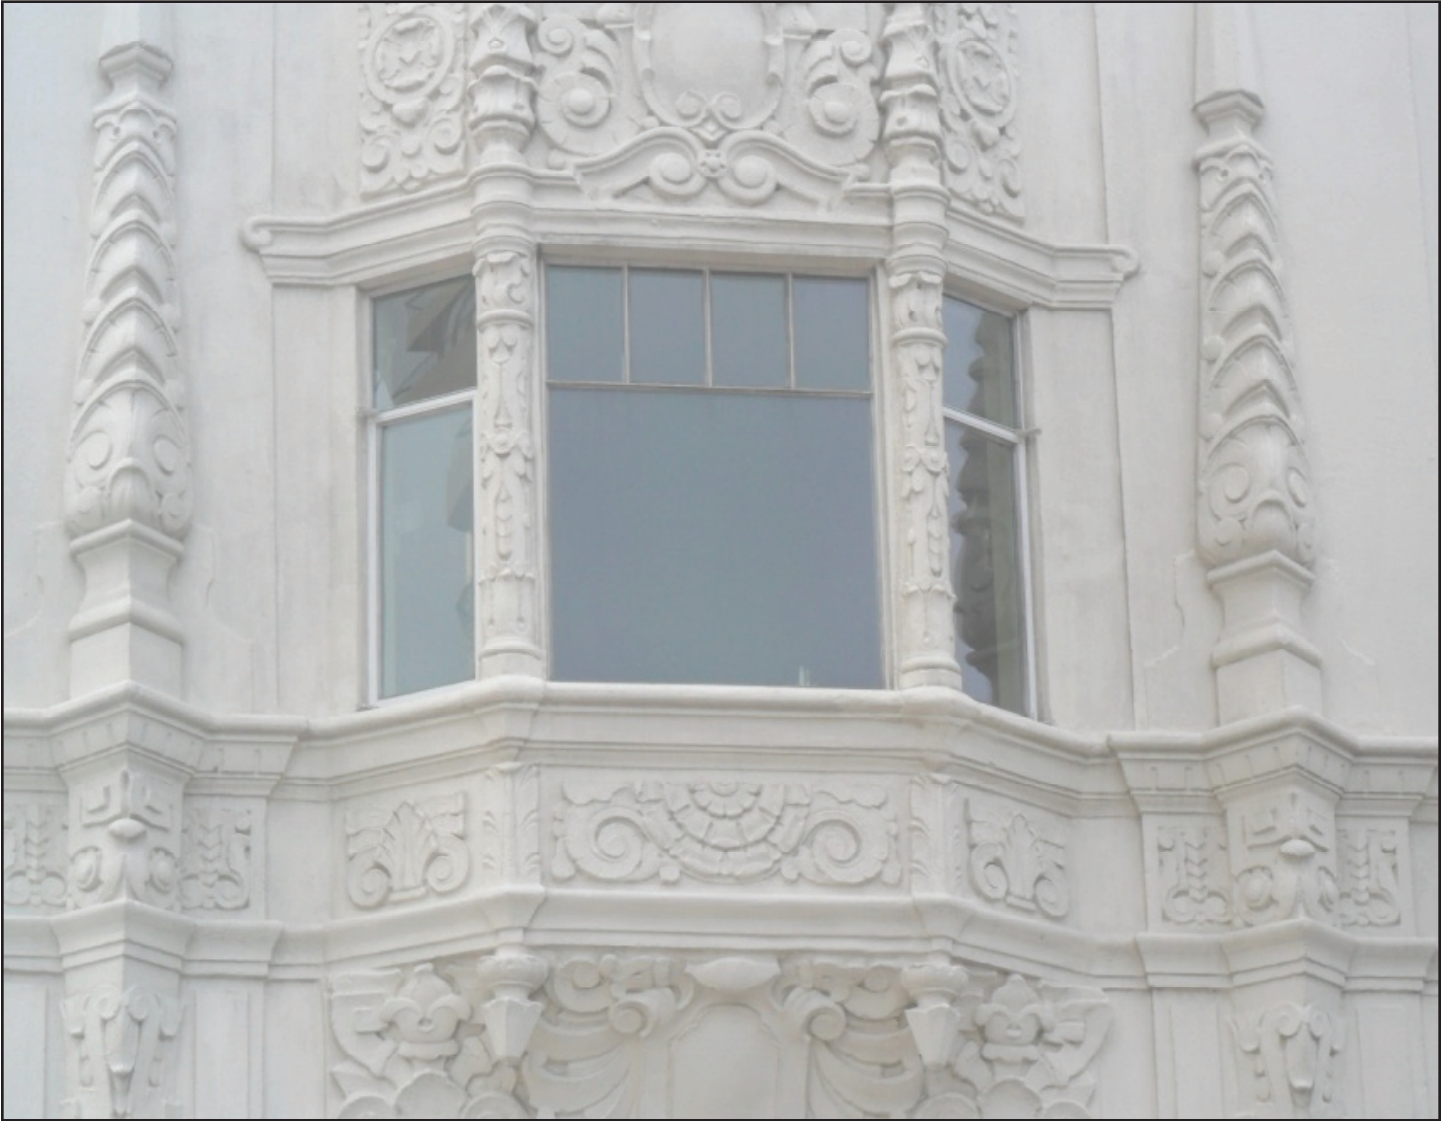
**Completed area. Note the intricate detailing and ornamentation.  
The four vertical elements of the window are made of GFRC.**

Ornamental concrete elements were replaced with GFRC. Polyurethane sealants were gunned into the concrete-window joints and other moving cracks (4,500 LF). And lastly, a breathable, waterproof coating (1,200 gallons) was rolled onto the entire exterior wall.
