## SWR INSTITUTE TRINITY AWARD SUBMISSION

Window and Exterior Wall Repairs, Hogan Building, Northwestern University

2205 Tech Drive, Evanston, Illinois

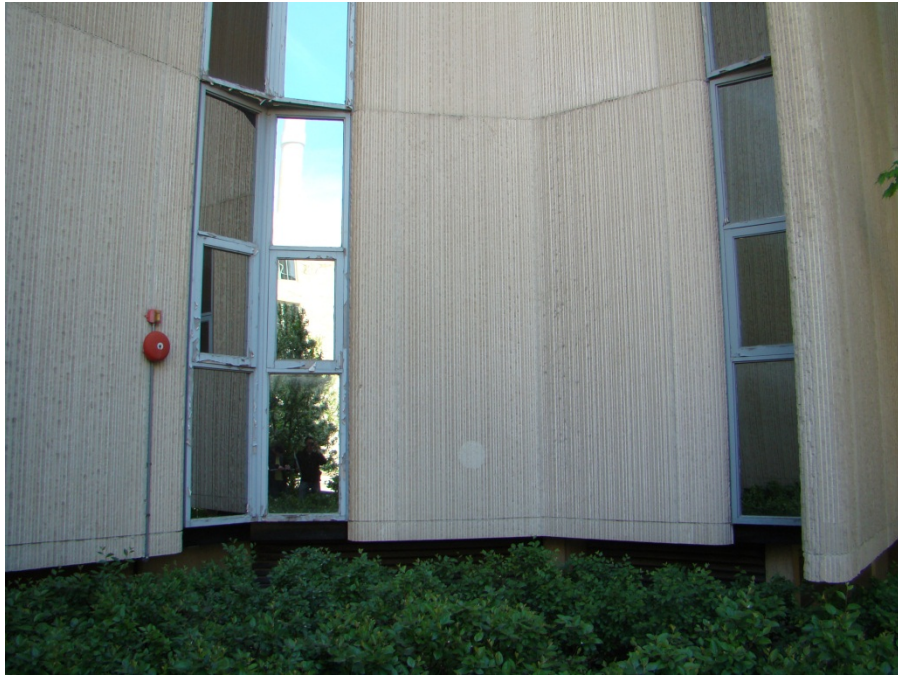
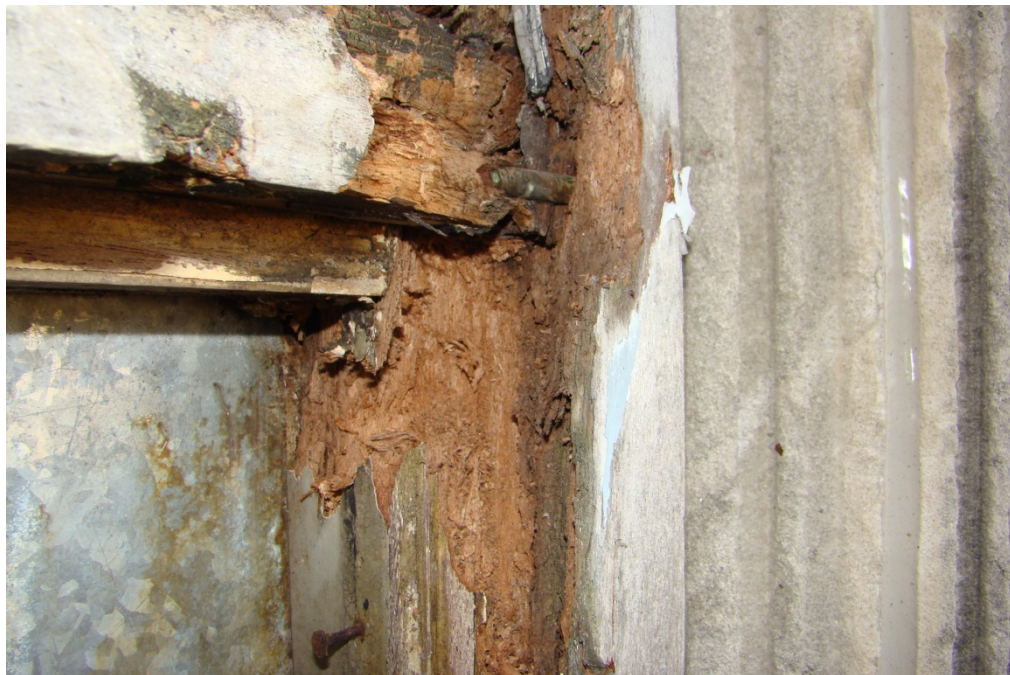
The Owner originally retained the Engineer to design new windows for the building due to extensive paint peeling, poor thermal performance, and air and water infiltration. However, after the initial evaluation by Engineer, the existing window frames were found to be in generally good condition despite some localized rotting (Figures 3 and 4).

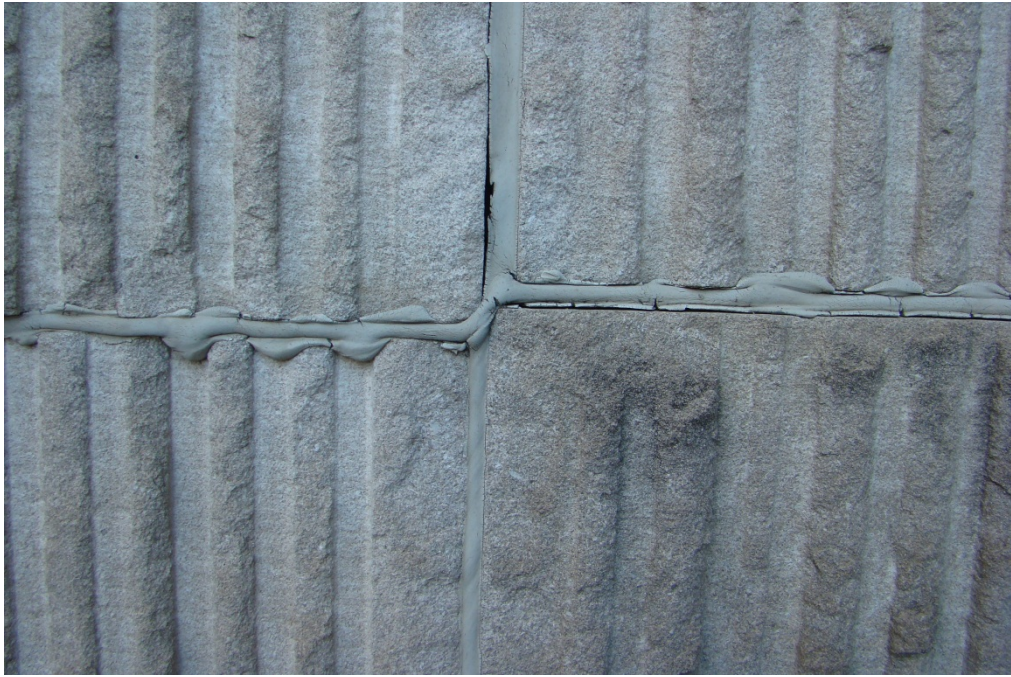
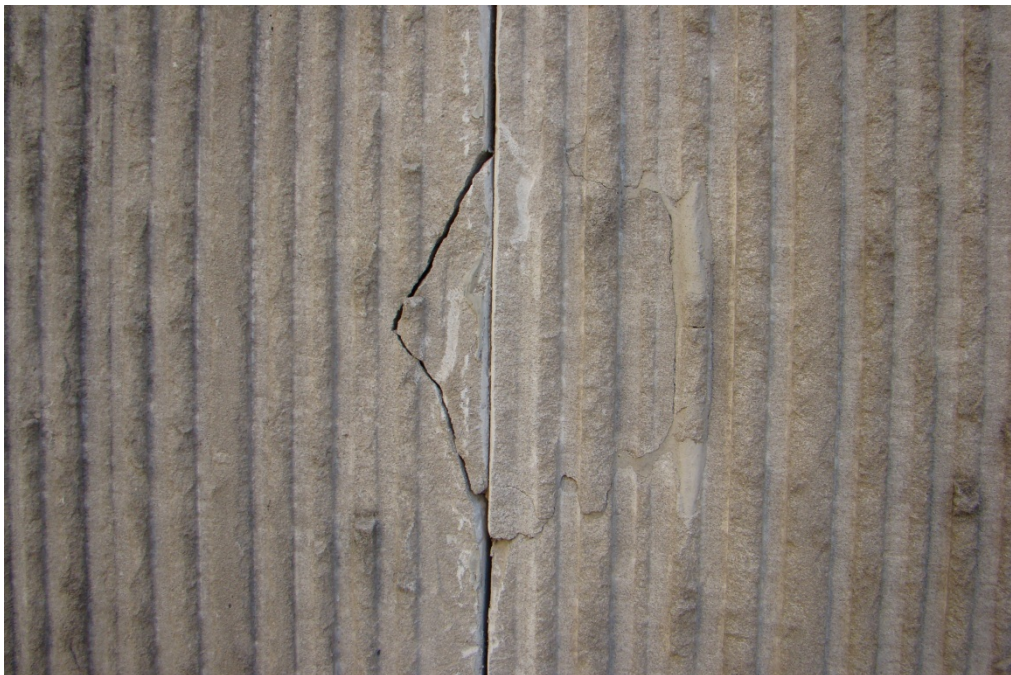
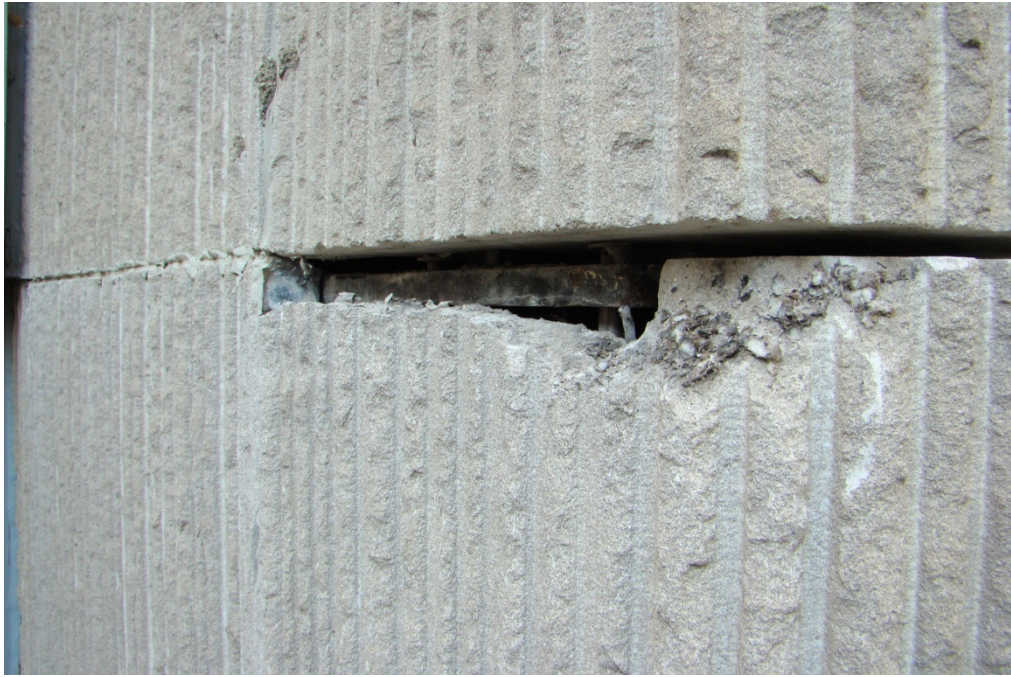
2. The existing limestone cladding panels were repaired and their sealant joints were replaced. The scope of work was specified to address shifting of the limestone panels due to creep in the lead shims used during original construction. In addition, cracking of panels due to corrosion and movement in the anchors and supports was specified. The scope of work included the following:

During the evaluation of the windows, the Engineer also found significant distress in the limestone panels. The limestone panels had shifted in many locations, particularly at the wing walls; and exhibited cracking and spalling (Figures 5, 6, and 7).

- a. Remove and legally dispose all existing limestone-to-limestone and all other sealant joints and backer rod material.
  - b. At all horizontal joints of wing walls, grout the space between the steel support member and bottom of the upper limestone panel as shown on Drawings.

- c. Provide new sealant and backer rod in all joints as shown on Drawings.
  - d. Route and seal existing cracks in limestone panels where directed by Engineer on a unit price basis.

- e. Repair delaminated and/or spalled limestone where directed by Engineer on a unit price basis:
    - 1) Perform Dutchman repairs as shown on Drawings.

- 2) Perform cementitious mortar patch repairs as shown on Drawings.
  - f. Remove and replace cracked limestone bottom sections at wing walls where directed by Engineer.

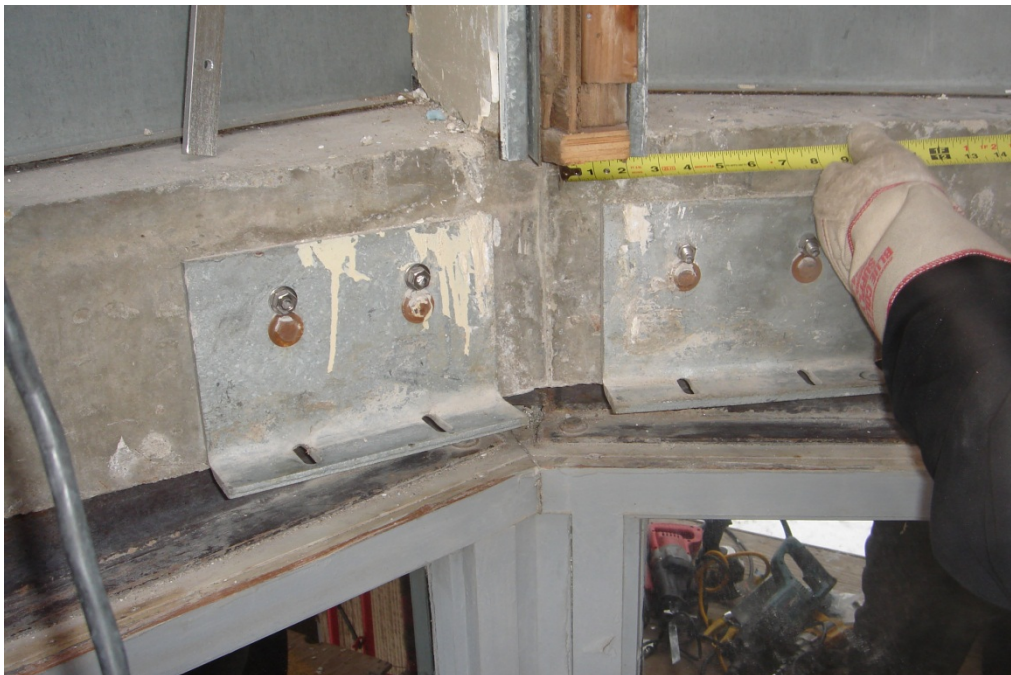
Figure 8

Although the design provided for new gravity support brackets for the windows, these brackets could not be installed. These brackets were needed to address the improper original installation of gravity support brackets during original construction (Figure 8). To address this issue, supplementary anchors were added to the existing support brackets. This posed the challenge of drilling through steel and concrete simultaneously.

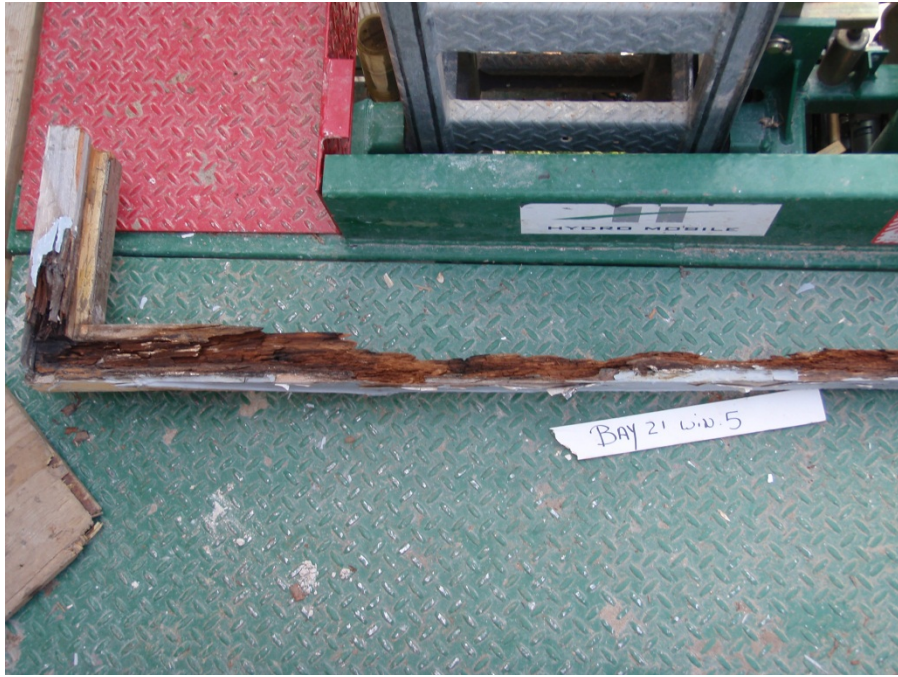
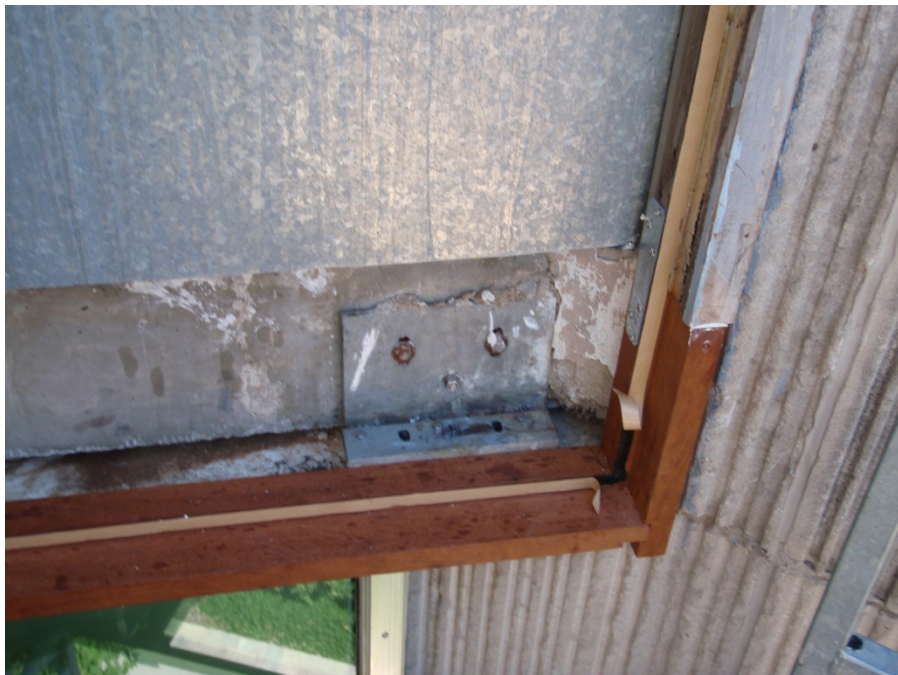
Other unforeseen conditions included encountering a few window wood frame members that had been significantly rotted (Figure 9 and 10). These members were replaced with new mahogany members and spliced in the field.

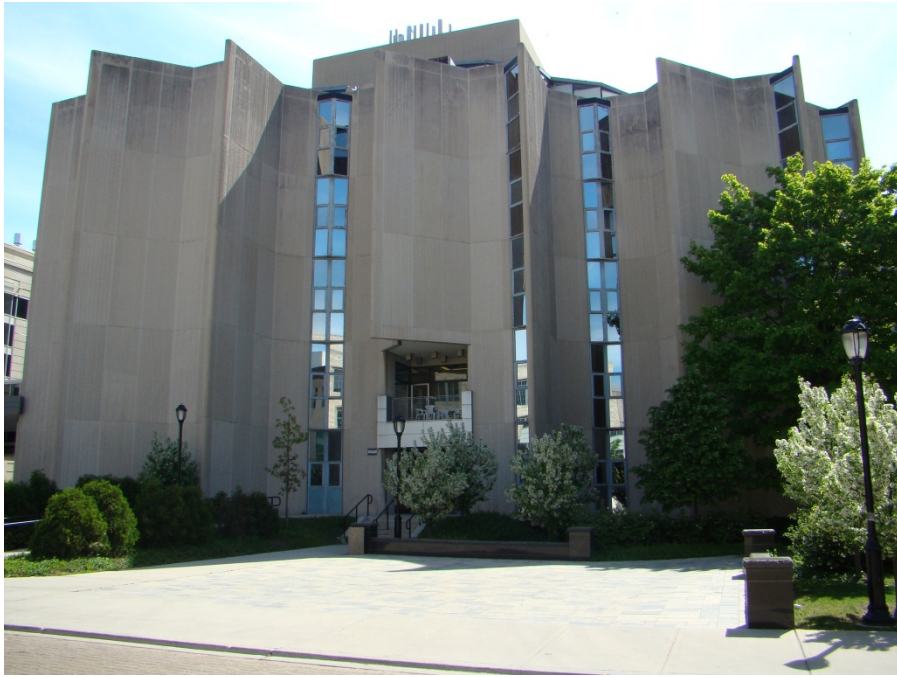
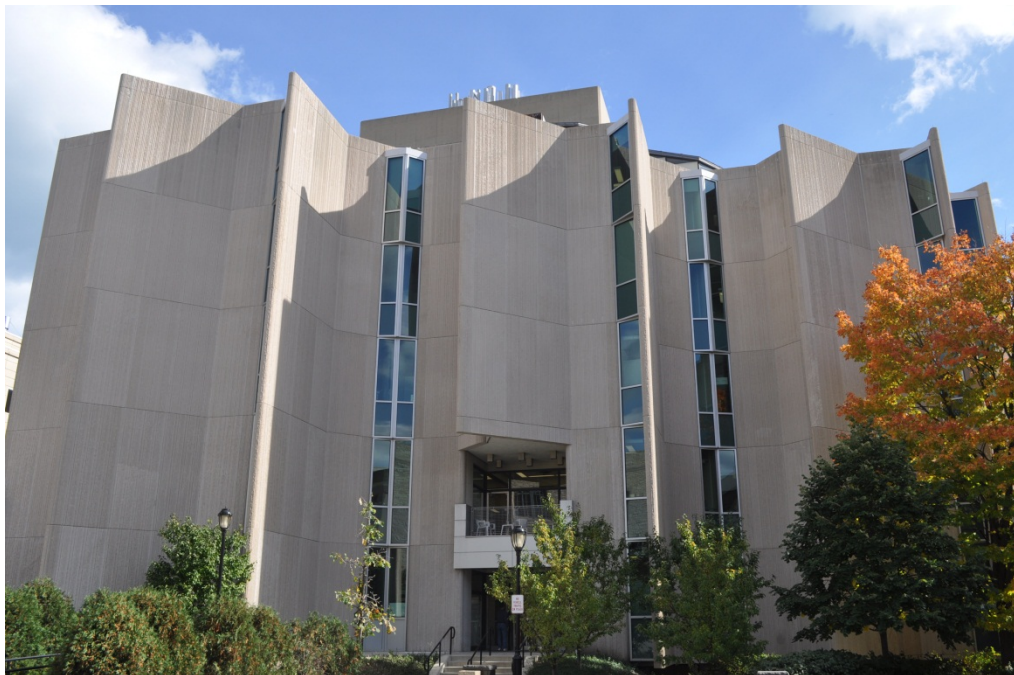
The appearance of the building was significantly improved through cleaning of the limestone, and the improved aesthetics of the windows (see Figures 11 and 12 for before and after photographs).
