## THROUGH-WALL FLASHING

### INTRODUCTION

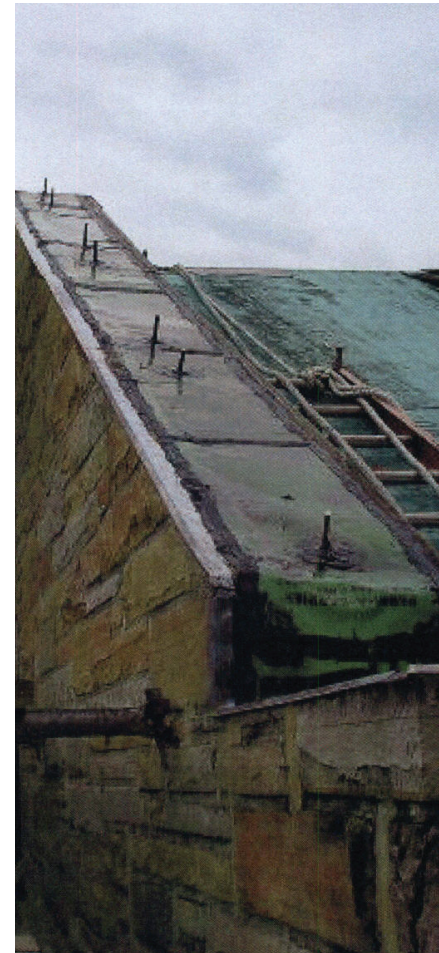
Precast coping bed flashing with dowels, flexible membrane and metal drip edge

**7. Coping Walls:** If walls are capped with a material other than sheet metal, bed flashing should be considered. Commonly this is associated with anchorage and flashing for precast coping units.

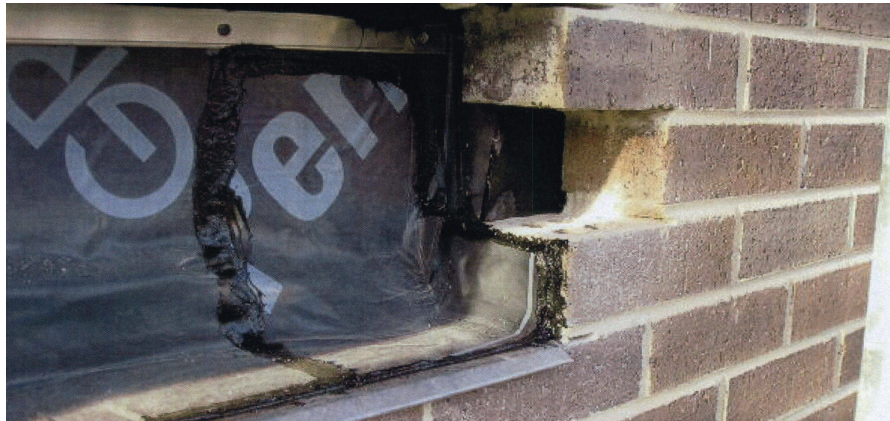
Typical flashing detail depicting top termination, flexible membrane, metal drip edge and end dam

**1. End Dams:** The containment of water laterally is accomplished through a damming mechanism at the end of a flashing run, typically of formed metal or membrane.

**2. Top Termination:** A common failure in most flashing exists when the top free edge is not properly sealed or secured. A compression bar and caulk joint resists against cavity mortar damage and water seepage in behind an unprotected top edge. It is common that the location of this termination be at least 8 inches above the horizontal flashing leg.

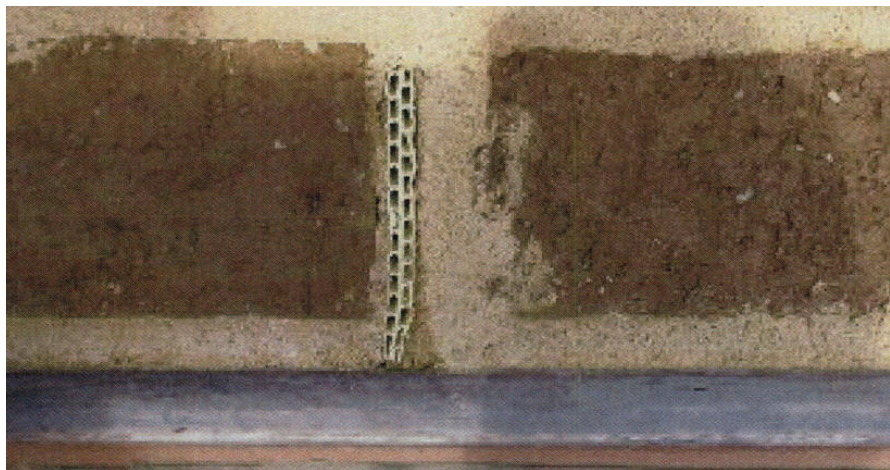
Cell vent weep outlet placed on top of flashing line and not on bed mortar

**4. Weep Outlets:** The dissipation of accumulated penetrating water is accomplished through a series of weep outlets typically spaced at 24 inches on center. The various types of weep outlets include ropes, plastic tubes, cell vents or open head joints. However, cell vents and open head joints are the most desirable type because they quickly dissipate accumulated cavity water. In any event, it is critical the weep outlets are placed directly onto the flashing plane and not elevated on top of the bed joint mortar.

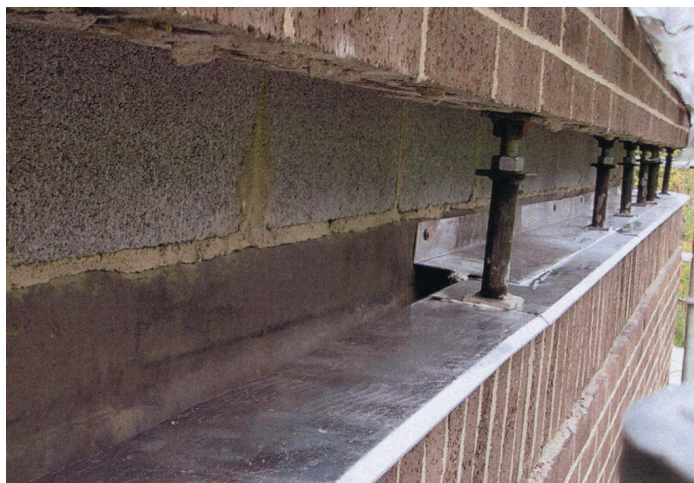
Excessive cavity with secondary metal closure piece

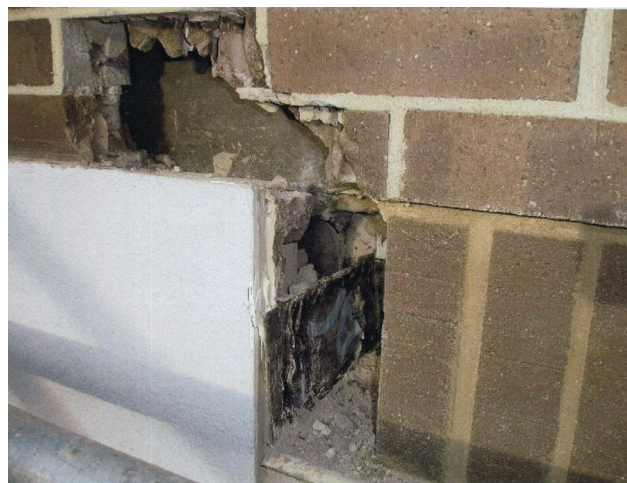
Inadequate flashing step down transition detail

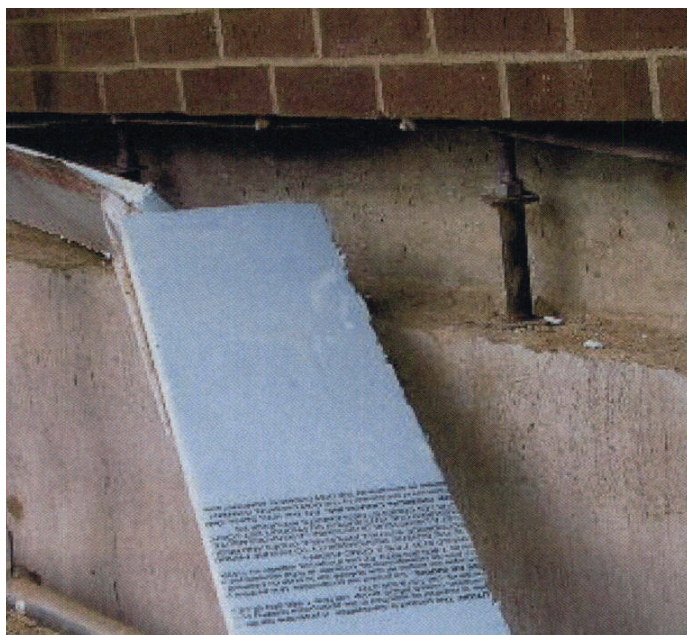
Irregular foundation wall surface in need of leveling

Depending upon the situation, the flashing component could be a multiple piece element. (i.e. drip edge, cavity closure piece, flexible membrane). When installing the flashing component, extreme care should be considered when analyzing discontinuities. Discontinuities are an interruption in the flashing run consisting of terminations and vertical step-up/down differences. The transition between two planes is essential. Another factor to consider is the substrate condition. Irregular surfaces should be leveled and voids filled to establish a smooth working plane. Finally, regarding

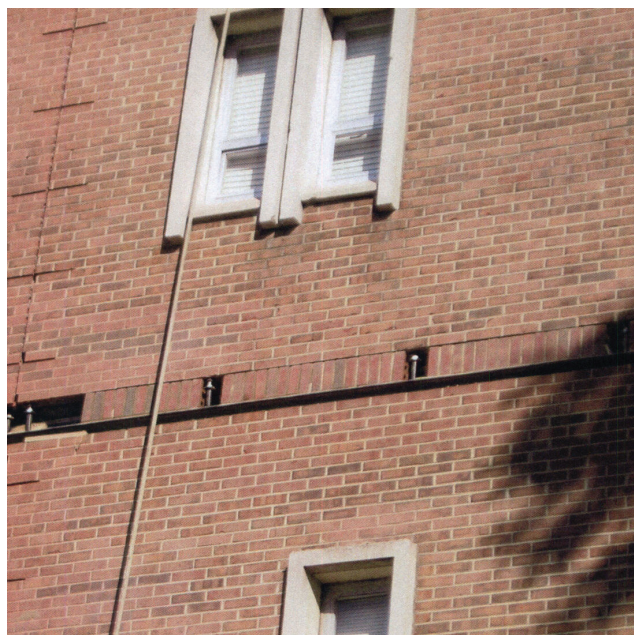
Brick replacement in sections to accommodate veneer dead load above

repairs, temporary shoring of remaining masonry units commonly dictates the number of lap splices in a flashing run. Flashing will be placed in sections to accommodate shoring jacks being removed one at a time. Due to varying site conditions, it is necessary to ensure the proposed remedial repair detail can be installed as designed. It is not uncommon to modify the approach to conform to actual building tolerances.

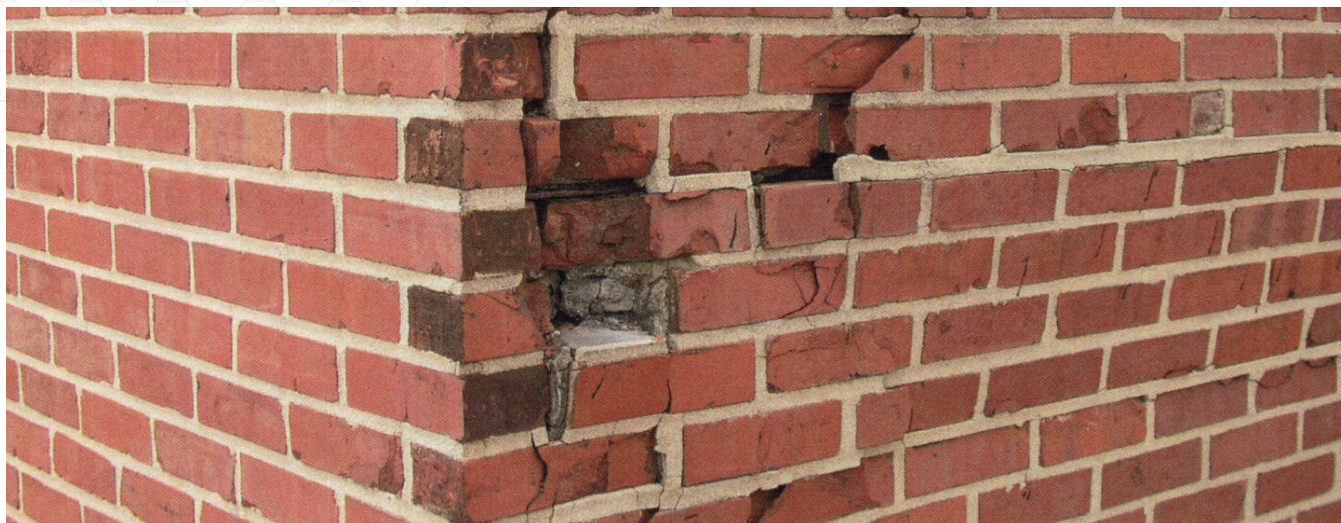
Masonry distress from trapped water and resulting steel beam corrosion activity

6. **Corrosion/Lintel Failure:** Corrosion staining on masonry surfaces is an indication of inadequate structural steel protection. If shelf angles and lintels are properly flashed, corrosion staining should not be evident. There is an additional concern that ongoing exposure of structural steel to drainage water will result in corrosion and loss of section, possibly rendering the support unsafe.

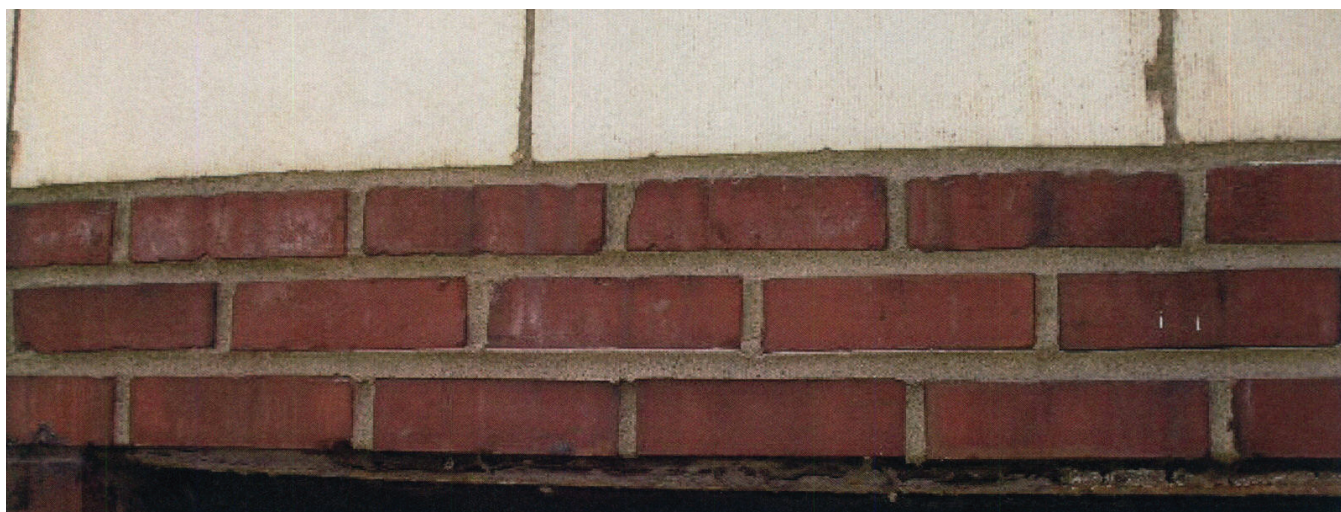
Mass Masonry Wall: Note mortar displacement, omission of weep outlets and excessive corrosion/deflection of the lintel support from trapped moisture.

4. **Omission of Weep Outlets:** As previously noted, weep outlets are a critical component to the functioning capacity of through-wall flashing. The omission of these outlets at an intended flashing line allows water to accumulate within the cavity space and possibly infiltrate through any minor detail flaw.

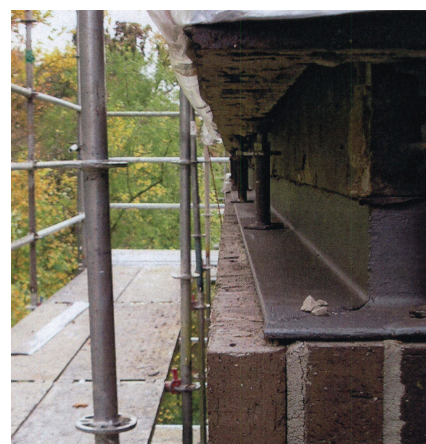
Steel shelf angle in need of extension to ensure adequate brick support

Shelf angles are a necessity in modern drained cavity wall systems. The purpose of shelf angles relieves the weight of the façade from bearing on itself to hanging from the structural system. Shelf angles are commonly supported from the structure with hangers. These hangers are either welded or bolted to the shelf angles. This attachment sometimes causes problems with flashing continuity

due to protrusions. Care should be taken in detailing these supports as well as performing a visual to ensure the support mechanism has not been compromised from corrosion. In addition, visuals should be made to ensure there is adequate steel extension necessary for suitable brick support.
