[Print This Form](#)**Project Details**

Project Title	Three Parkway Facade Repairs
Property Name	Three Parkway
Location	1601 Cherry Street Philadelphia PA
Entry Classification	Waterproofing
Project Cost (dollar amt)	832 000
Duration (calendar days)	158
Start Date (mm/dd/yy)	5/23/2011
End Date (mm/dd/yy)	10/27/2011

Scope of Work

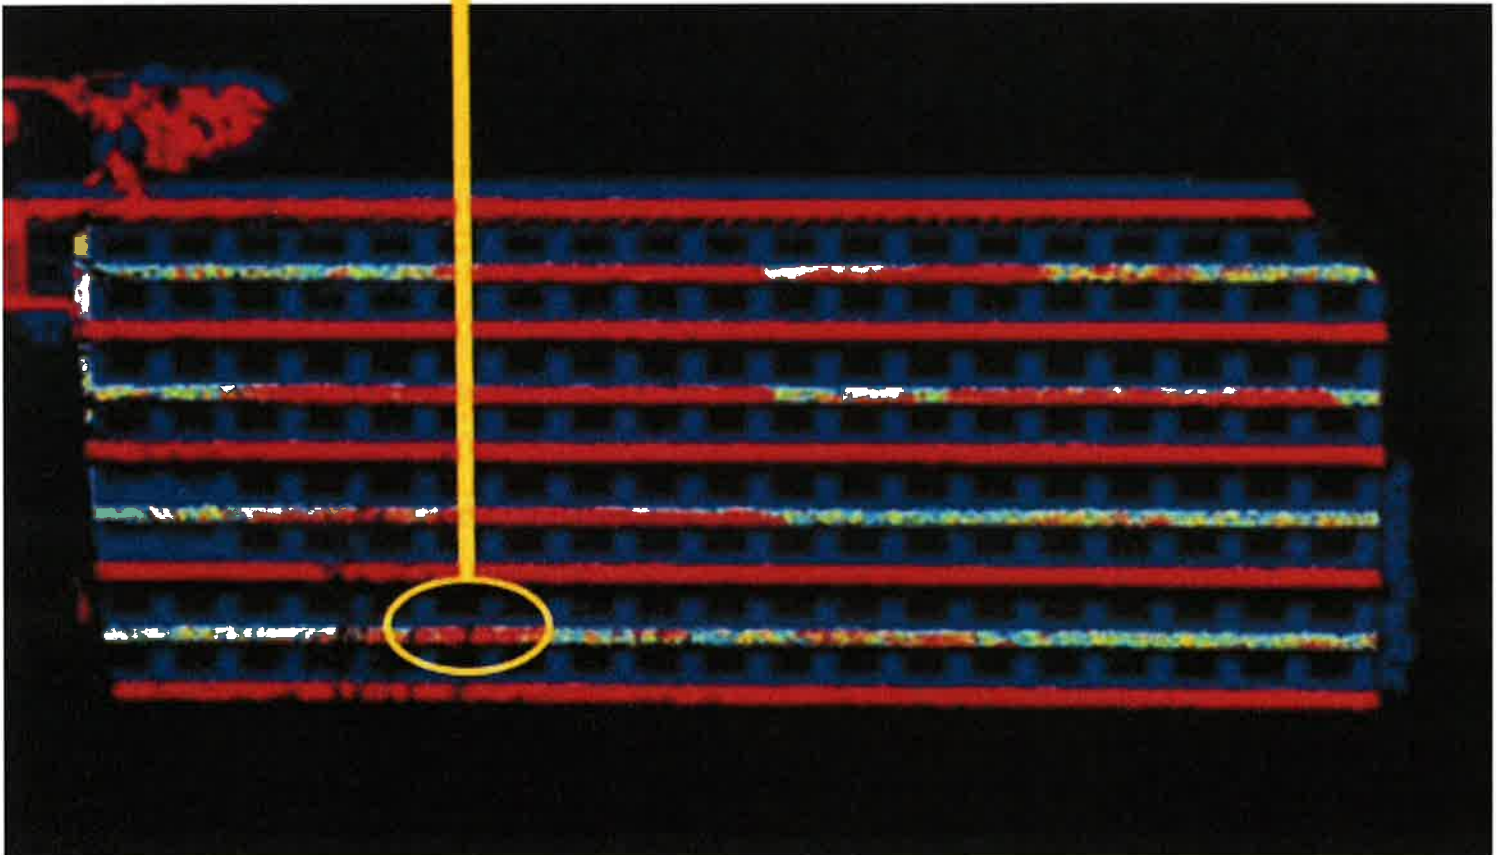
REMOVE AND REPLACE THREE BRICK COURSES TO INSTALL NEW FLASHING THROUGH SAWCUT OPENINGS AND ONTO UNDERSIDE OF EXISTING STEEL LINTEL

TEMPORARILY TURN-UP EXISTING FLASHING BEHIND REMOVED BRICK. INSTALL NEW FLASHING THROUGH SAWCUT OPENINGS AND ONTO UNDERSIDE OF EXISTING STEEL LINTEL SIX INCHES IN EACH DIRECTION FROM OPENING. RE-INSTALL EXISTING FLASHING OVERTOP.

REMOVE AND RE-INSTALL EXISTING BRICK FOR FLASHING INSTALLATION. LEAVE EVERY OTHER HEAD JOINT OPEN.

SAWCUT TWO-INCH WIDE OPENING THROUGH ENTIRE DEPTH OF PERPENDICULAR LEG IN EXISTING STEEL LINTEL. OPENINGS SHALL BE CUT EVERY TWO FEET ON-CENTER. DO NOT CUT LINTEL OVER CAPSTONES.

MEMBRANE FLASHING ADHERED TO STAINLESS STEEL FLASHING

STAINLESS STEEL FLASHING

When the design was arrived at to installed waterproofing at an atypical brick support location the constructability and condition of the existing steel angles was an unknown condition. Removal of corroded angles was not anticipated but was necessitated by their condition. In order to remove the steel angles and improve constructability and production the contractor developed a solution where temporary steel angles were placed upside down from their typical configuration to support a sloped brick condition above. The temporary angles were then supported by small steel clips slid onto the existing angle fasteners after removal of the existing angles. This temporary support allowed large areas of the flashing condition to be addressed at once while permitting angle replacement as needed.

their typical configuration to support a sloped brick condition above. The temporary angles were then supported by small steel clips slid onto the existing angle fasteners after removal of the existing angles. This temporary support allowed large areas of the flashing condition to be addressed at once while permitting angle replacement as needed.
