SWR INSTITUTE TRINITY AWARD SUBMISSION

Exterior Wall and Roof Repairs, The 1717 Rhode Island Avenue Building, Washington, DC

1717 Rhode Island Avenue NW, Washington, DC

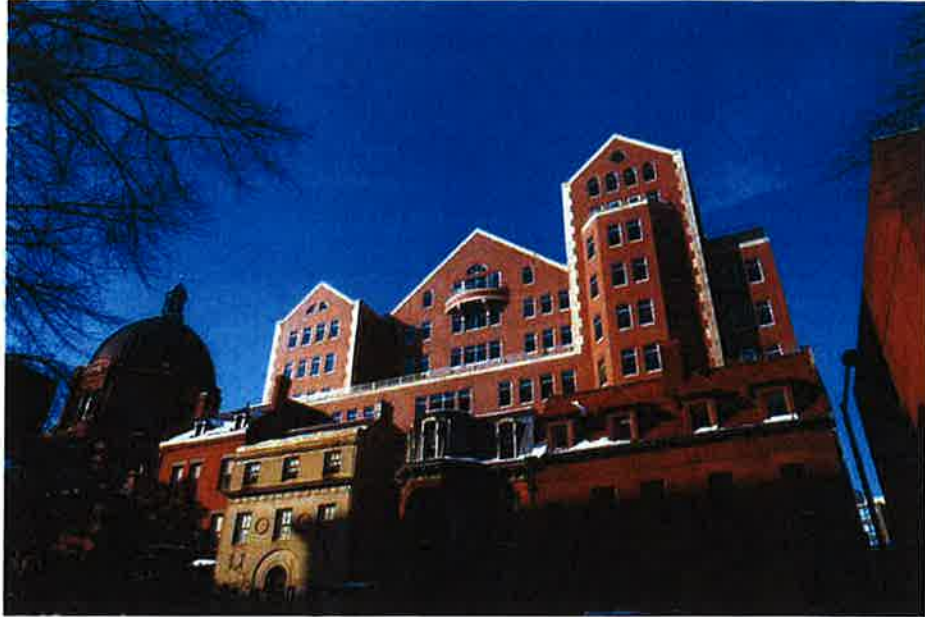
Figure 1

The 1717 Rhode Island Avenue Building is a 10-story Class A office building located in the historic DuPont Circle neighborhood of Washington, DC (Figure 1). Original construction of the building in 2004 included historic preservation and integration of four 4-story townhomes originally built between 1877 and 1886. The building also abuts historically significant St. Matthew's Cathedral.

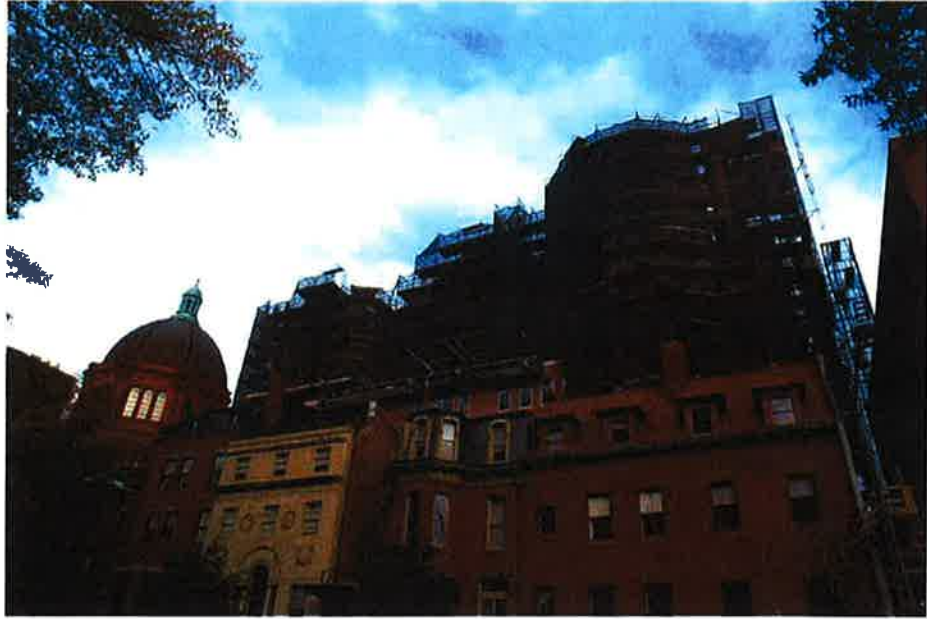
Figure 11

3. Access to work areas was difficult and onsite storage was limited. A combination of fixed scaffold, swing stages, and mast climbers were used to access the work (Figure 11 and 12). Support of much of this equipment was by the existing structure, since much of the work was above building terraces or adjacent properties. The roofs of the historic townhomes and St. Matthew's Cathedral had no capacity to support any construction load. As such, evaluation of several structural components of the building was necessary to ensure they were adequate to support the anticipated construction loads.

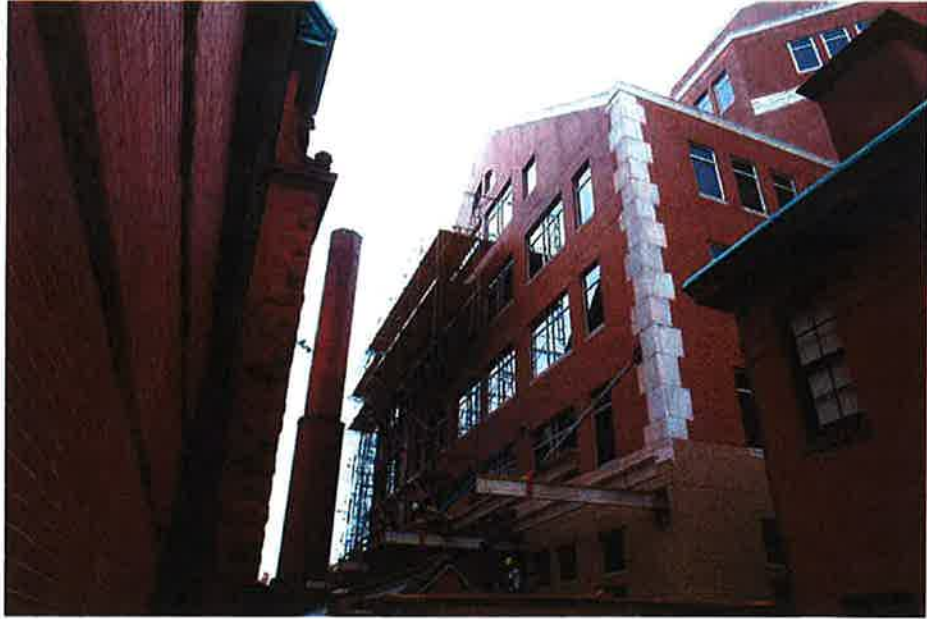
Figure 13

3. Access to St. Matthews Cathedral roofs were required to complete repairs to the exterior walls over those roofs on the west elevation of the building. Substantial roof protection was required to prevent damage to those roofs. However, since the roofs were not capable of supporting any significant weight, a platform system had to be constructed above the roofs and attached only to the 1717 building structure to support fixed scaffold (Figure 13).

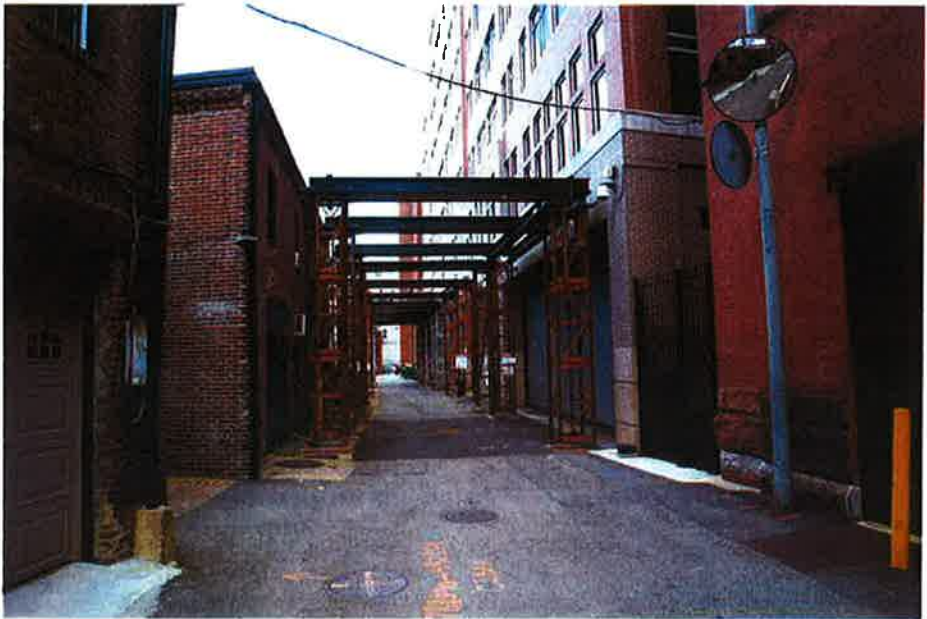
Figure 14

4. Work on the north elevation of the building was over a public alley that was required to remain open to the public, as well as delivery and garbage trucks. As such, a tall heavy-duty canopy was required over the full width of the alley (Figure 14).

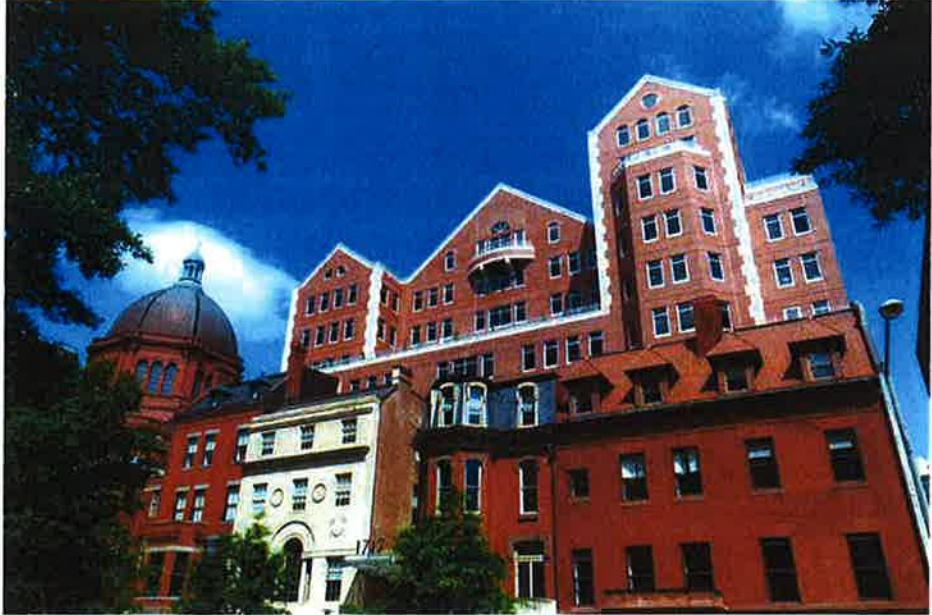
Figure 15

Prior to initiation of repairs, a mock-up phase was implemented to ensure the specified repairs were practical to perform. Material color matching was performed to ensure the general appearance of the building did not change once repairs were complete (Figure 15).
