## SWR INSTITUTE TRINITY AWARD SUBMISSION

Window and Exterior Wall Repairs, Hogan Building, Northwestern University

2205 Tech Drive, Evanston, Illinois

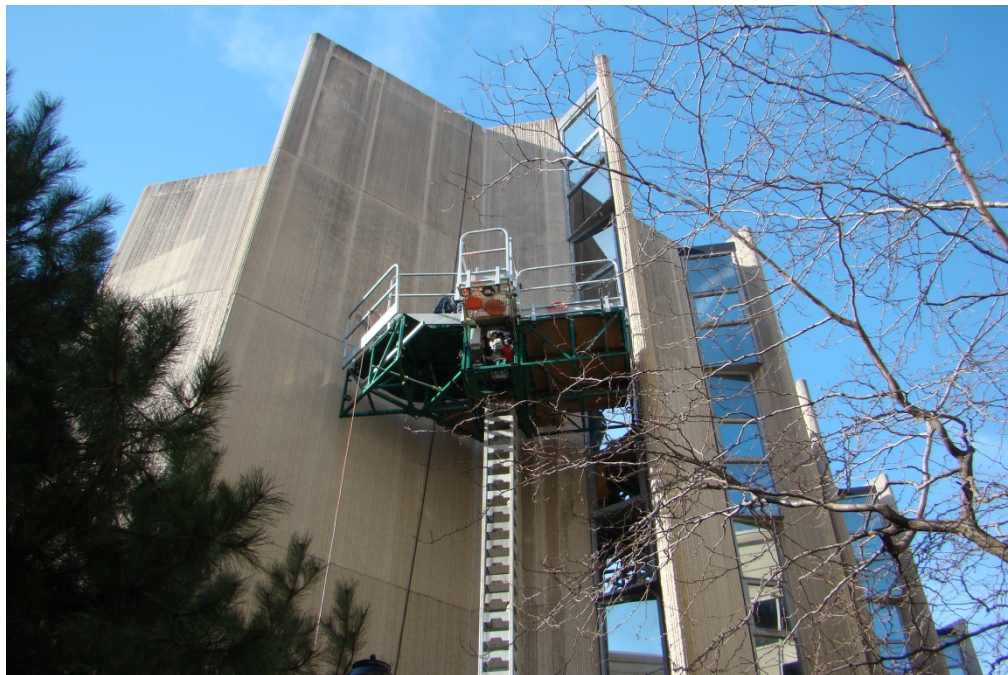
Figure 16

The Contractor utilized mast climbers to access the window tiers (Figure 16). Mast climbers were selected due to their load capacity to carry large panes of insulated glass, etc.; and their stable platform.

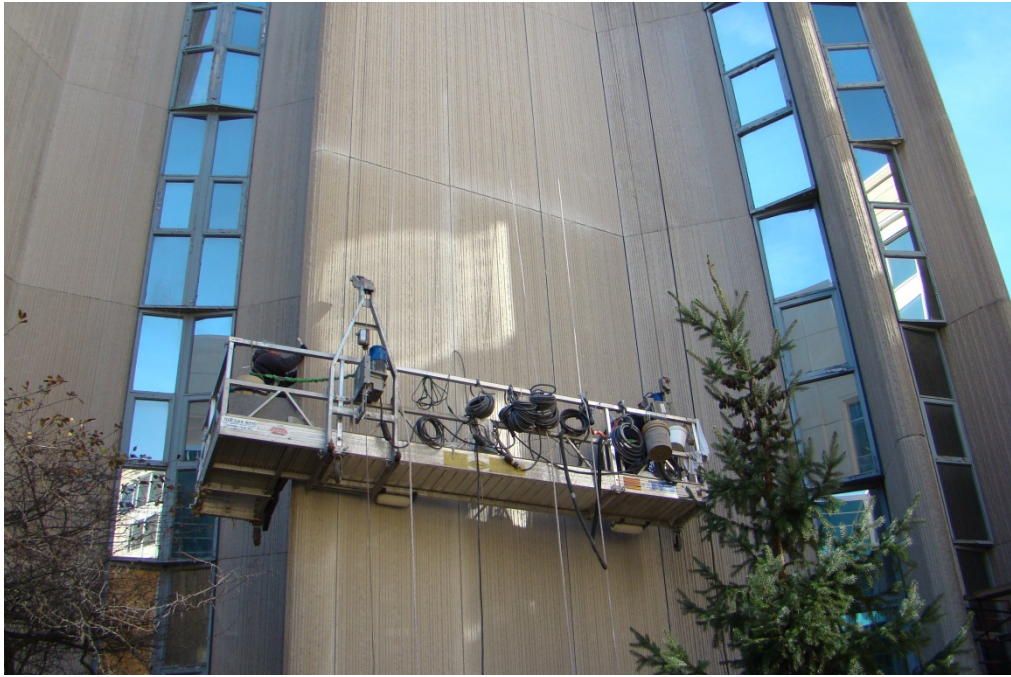
Figure 17

The limestone panels were accessed using conventional swingstage scaffolding (Figure 17).
